Post- ecologyzation disasters- Case of Rusca Montana and Ruschita localities

Abstract- After some wrong ecologyzations, the phenomena of chemical pollution and radioactive heavy metals may increase. Also, the geomorphological stability of area can cause major disasters. In this paper it shows the real situation from an area where non-radioactive minerals were extracted but had high levels of uranium.

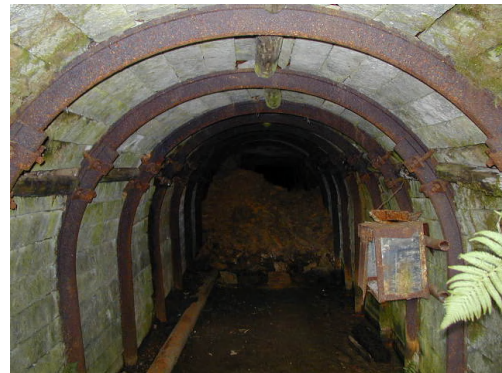
Fig. 1- The 3 ISEM collapse- gallery

If in the period between 1963 year and 1969 year, the mines was temporaly closed because of some wrong works (was outburstet to much in few galleries, in ceiling area) all three levels are collaoapse in falls. To continue the ore transportation from dump to floating station, the mountain is perforated, under galleries, by a tunnel at 917 altitude where was and the preparation foundry. Instead of the three systems of galleries is form a cone which was near by the Colony.

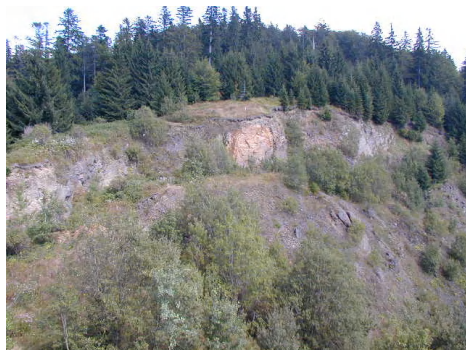
Fig. 2- „Boul” Peak- collapse

This disaster increase the contamination of area (of water the 6th time and of vegetation the 3th time).

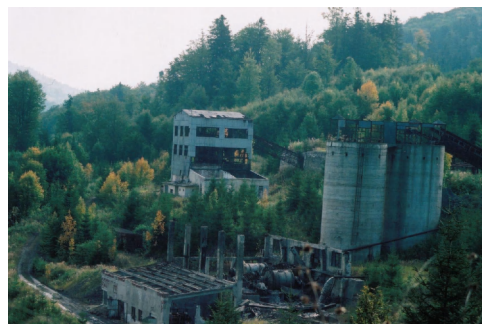
Fig. 3- The 917 complete flotation

Pumps flow over, the contaminated water directly in near river. At these phenomena accumulate and the contamination with flotation pulp. The radiometric evaluation, gamma global, show this value 900- 1800 Cps (1720 Bq/kg). The transport of processing ore was executed with trucks descover on the mountain road which caused the contamination of water from downstream to Voislova railway station (where was the area of depositing and boarding in train). After 2000 year the ecologization works of all galleries and annex-stations begin. In fact cut the iron (larries, locomotives, transformers, engines, pumps, well station, pipes, rails, metal fittings from mines), the buildings are demolished (barracks, annex-building) and at the entry of gallery is built a brick wall. The slopes are not solidify, the retaining walls were not built and the mining works are not revegeted. By those ecologization work, the disaster is increase, the radioactive and heavy metals pollution may be uncontrollable.[3] In 2000 year, after some rain with devastating phenomens, take place a dislocation of an sterile slope which destroy some houses and pile up 6- 8 m of tailings. The slag ironstone slopes, mixed with branerite, are pushed to upstream and the contaminated water arrives in potable water tanks from Ruschita locality. In the area with mountain roads where the support wells are collapse, some of the mountains slope with their vegetation are dislocated.

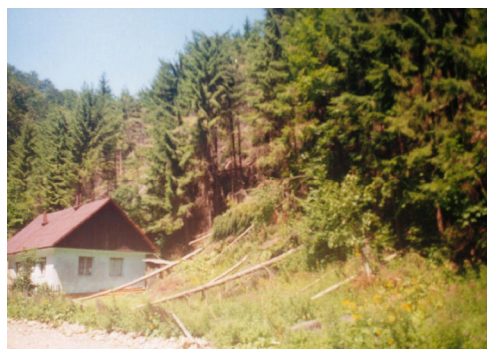
Fig. 4- Dislocated slope

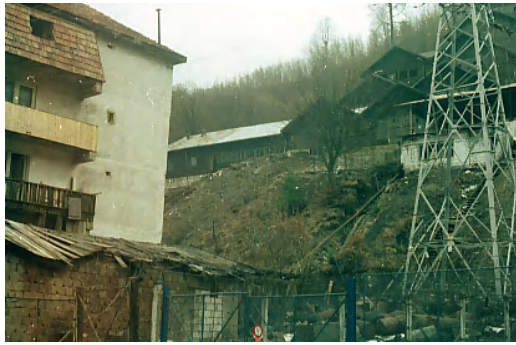
Fig. 5- „Ruschita” locality- lead flotation

In the middle of the Ruschita locality, the slag slopes of lead flotation arrived to enter on windows at lower levels of apartment building.

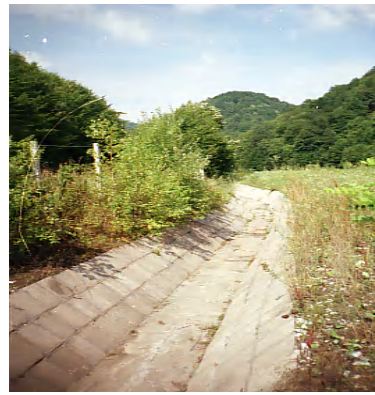
Fig. 6- „Porcu” settling pit

That material will not only eights valley, but will block the road and will contaminate a considerable length on "Padeş" valley, till after the confluence with the "Bistra" river. After some analysis, in the settling pit, were identified rare metals (gold, silver), heavy metals (lead, copper, zinc) even radioactive metals (uranium, thorium, yttrium); dislocation potential is high because was extract large amounts of marble blocks from dam protection; marble blocks which was used in constructions and local industrialized to obtain construct products (marble powder and kibble for mosaic). The displacement phenomenon can be amplified by the destruction of vegetation situated on dam. Both, the horizontal surface and the outer slope is crossed by ditches caused by rainwater flow; considering that the base is not stabilized in any way, are high chances that the dam to dislodge.

From efectuated researches, results that would be necessary a new works ecologyzation, correctly executed which to be focused on all slopes stabilization with mining works and situ treatment of water which draining from galleries.
