# Seismic vulnerability assessment of historical urban centres

Teză destinată obținerii titlului științific de doctor inginer la Universitatea Politehnica Timișoara în domeniul Inginerie Civilă

arh. Iasmina Apostol

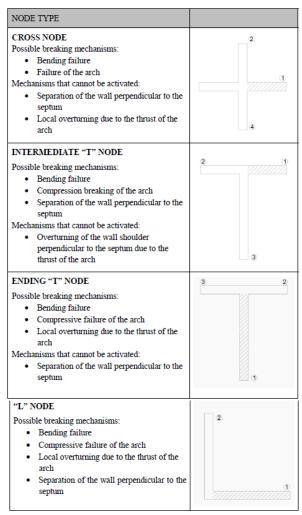
The possible failure mechanism are related with the type of nodes that form between structural walls, as presented in Figure 2.26 [109].

Figure 2.26. Effects of different type of nodes [109]

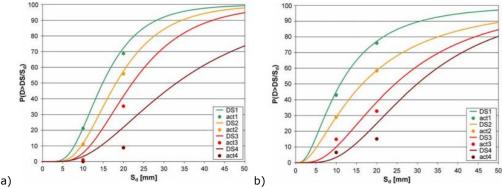
Using the hybrid procedure, there were designed damage histograms and vulnerability curves for the building classes that were investigated (Figure 2.39). As expected, the buildings made in stone masonry proved to be more vulnerable than the ones made in brick masonry [50].

Figure 2.39. Vulnerability curves for: a) brick masonry buildings; b) stone masonry buildings [50]

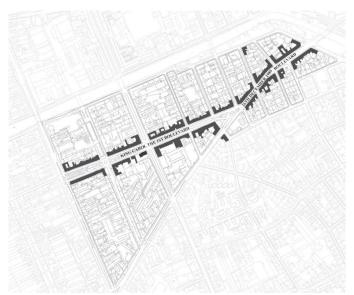
Figure 3.14. The investigated historical masonry buildings from Iosefin district

There were chosen for investigation the most representative historical buildings, as presented in Figure 3.14 for losefin district and in Figure 3.15 for Fabric district. The total number of the buildings is 105, from which 68 are located in Iosefin and 37 in Fabric.

The study involves a large number of historical buildings located in the two historical areas outside the city centre of Timisoara, which are losefin (Figure 3.14) and Fabric (Figure 3.15). There were preliminary investigated a total number of 105 buildings, 68 from losefin area and 37 from Fabric historical district. For each of this historical masonry buildings, there were studied aspects such as constructive system, regularity, symmetry, aspects regarding adjacent buildings, possible valuable artistic assets and others, as presented in 3.1.2. For all this buildings, there was performed the empirical seismic vulnerability assessment based on the Vulnerability Index Methodology [81].

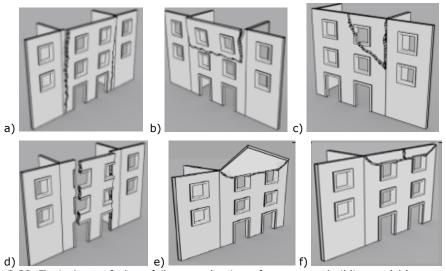
Figure 3.39. Typical out-of-plane failure mechanisms for masonry buildings: a),b) overturning because of lack of connection, both sides; c) overturning in correspondence of the piers; d) overturning due to lack of connection, one side; e), f) arch failure; [191]

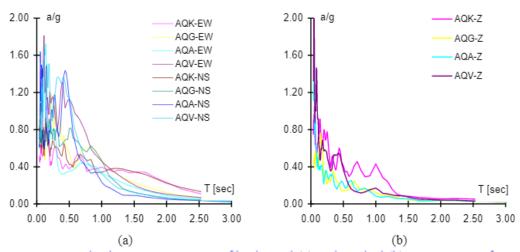
Figure 3.43. Comparison between: a) horizontal and b) vertical components of L'Aquila earthquake from 6th April 2009 [194]

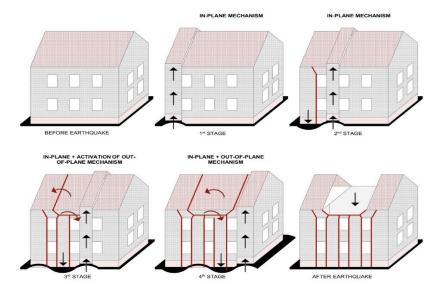
Figure 3.50. Particular combination of in-plane and out-of-plane failure mechanism for masonry building in the epicentre of shallow earthquakes [174]

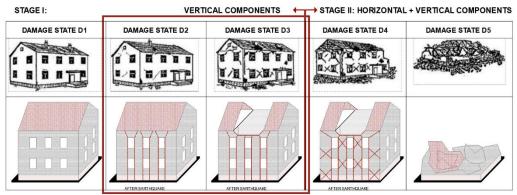
Figure 3.51. Correlation between real damage observed on site and expected damage states for similar masonry buildings in the near-field areas [174]

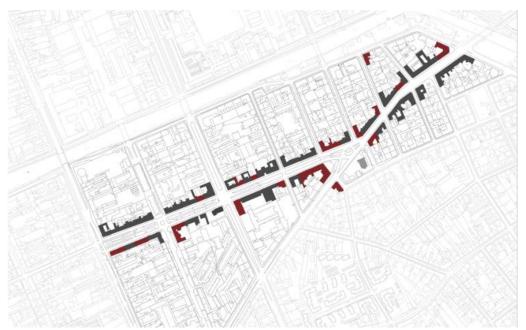
Figure 3.53. Selected historical masonry buildings from Iosefin district for mechanical analysis

For the detailed investigation, there were selected 25 historical masonry buildings, considered as representative for the entire area. For this buildings, there were made complete survey, on-site investigation and experimental tests. The location of the chosen buildings is presented in Figure 3.53 for losefin district (19 buildings) and in Figure 3.54 for Fabric district (6 buildings). For all of them, there was performed the mechanical seismic vulnerability assessment with Tremuri software [120].

Tremuri software was used for all 25 detailed investigated buildings from losefin and Fabric historical districts, as described in Figure 3.53 and Figure 3.54. The analysis was performed on each masonry building, considered as individual structural unit. The purpose was to determine the first type of decay that tends to appear in the structure, the top horizontal displacement and the maximum shear forces. The analysis was performed also based on typological class, so a proper comparison with the empiric methodology could be possible. The detailed survey of all 25 investigated buildings is presented in Appendix B.

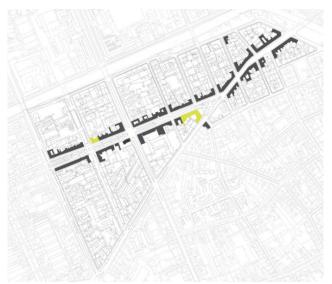
Figure 3.59. The historical masonry buildings from Iosefin district from where were extracted burnt clay bricks for experimental tests

For more detailed information about the bearing capacity of the structural elements of the investigated historical masonry buildings, there were performed small experimental tests on bricks extracted from 4 of the case study buildings. The bricks were extracted both from basement, ground floor, top floor and attic, from three historical masonry buildings from losefin district (Figure 3.59) and from one historical masonry building from Fabric area (Figure 3.60).

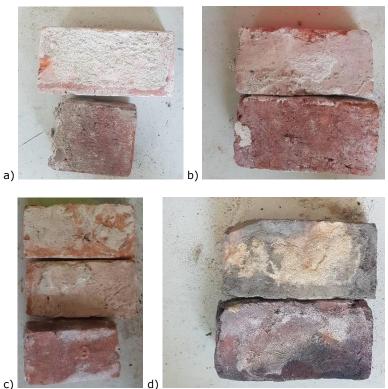
c) d)
Figure 3.62. The tested burnt clay brick: a) Merlin Theatre, Iosefin; b) Sinaia Palace, Iosefin; c) King Carol the 1<sup>st</sup> no. 28, Iosefin; d) Mercur Palace, Fabric [211]

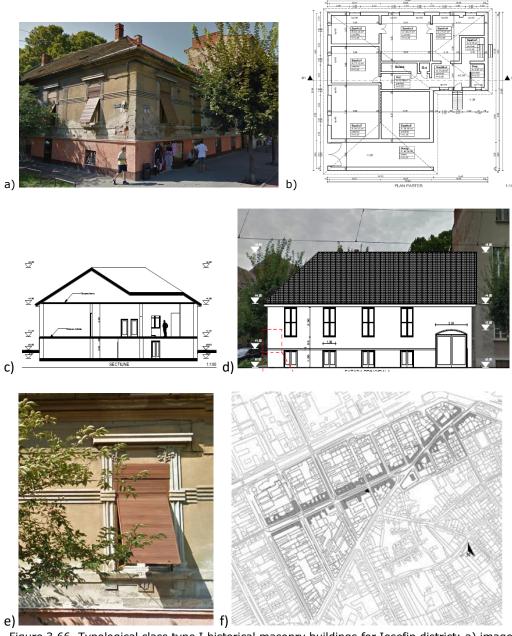
Figure 3.66. Typological class type I historical masonry buildings for Iosefin district: a) image of the buildings in the current state; b) ground floor plan; c) section; d) façade; e) architectural-artistic elements; f) location

Usually, buildings from typological class I are very poor in architectural-artistic details. Also, their roof is not very complex and not very tall, because the height of a roof represented in the past the visual and urban landmark that the buildings was important. Some representative examples of building typology I are illustrated in Figure 3.66 for losefin district and in Figure 3.67 for Fabric historical area.

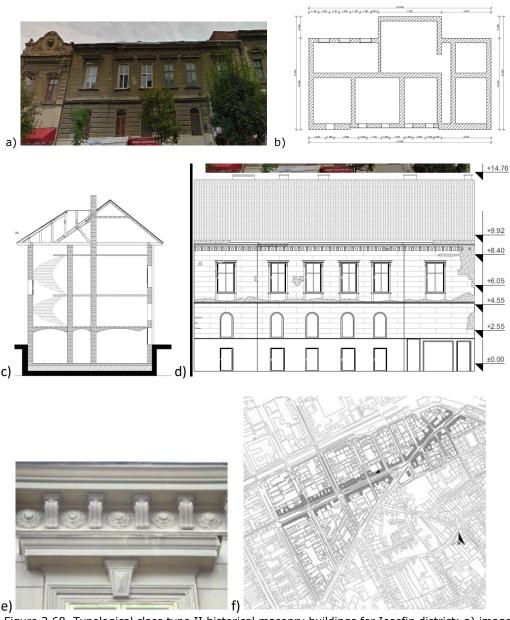
Figure 3.68. Typological class type II historical masonry buildings for Iosefin district: a) image of the buildings in the current state; b) ground floor plan; c) section; d) façade; e) architectural-artistic elements; f) location

In case of the typological class type II, the decoration are more visible and the buildings tends to become bigger. At many buildings from this typological class, the basement tends to become higher, accommodating commercial functions. There can be seen corner bosses, frontons and balconies with decorated balusters. Some representative examples of building typology II are illustrated in Figure 3.68 for losefin district and in Figure 3.69 for Fabric historical area.

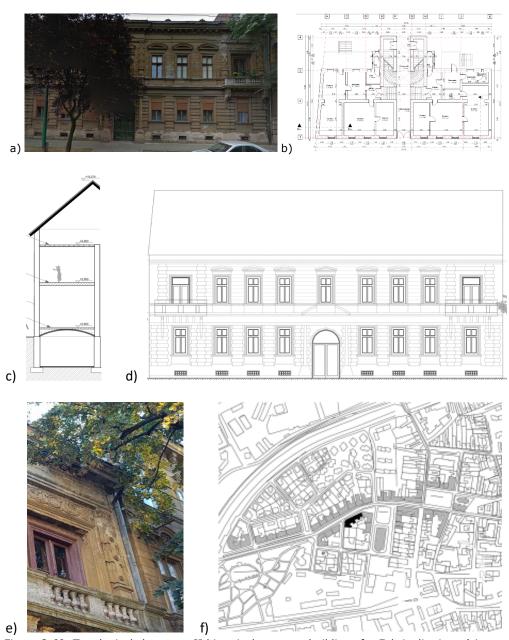
Figure 3.69. Typological class type II historical masonry buildings for Fabric district: a) image of the buildings in the current state; b) ground floor plan; c) section; d) façade; e) architectural-artistic elements; f) location

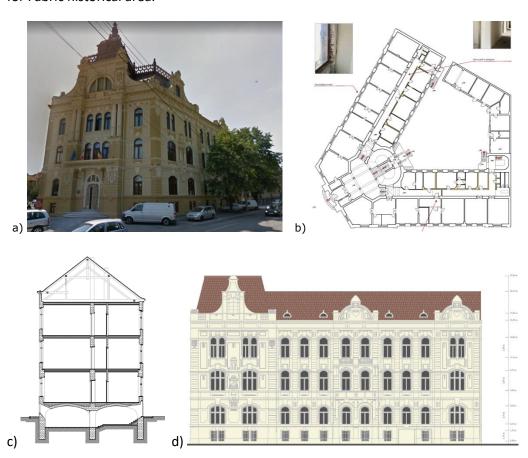
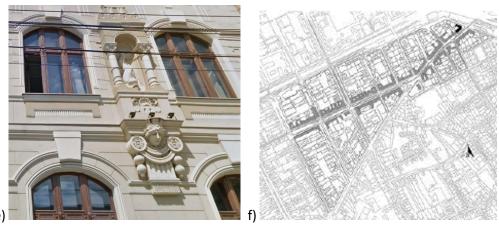
Figure 3.70. Typological class type III historical masonry buildings for Iosefin district: a) image of the buildings in the current state; b) ground floor plan; c) section; d) façade; e) architectural-artistic elements; f) location

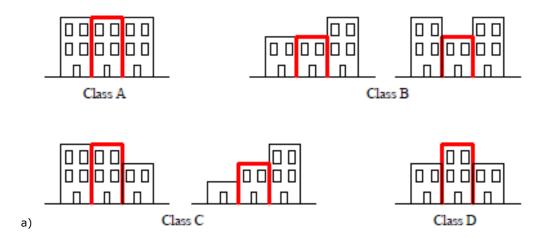
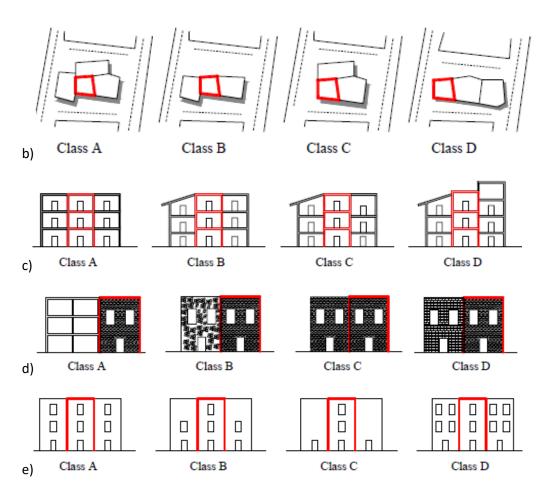
Figure 3.77. The assignment of the possible vulnerability classes for the vulnerability form: a) in elevation interaction; b) in plan interaction; c) staggered floors; d) structural heterogeneity; e) percentage difference among opening areas of adjacent facades [220]

The assignment of the four possible classes (A,B,C or D) in the vulnerability form is presented in [220].

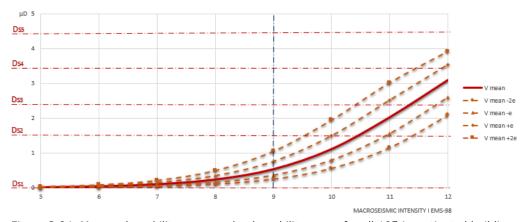
Figure 3.84. Mean vulnerability curve and vulnerability range for all 105 investigated buildings in Iosefin and Fabric district, for first 10 parameters on the vulnerability form

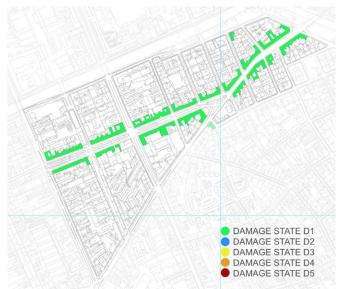
Figure 3.88. Seismic vulnerability map for Iosefin historical district, for first 10 parameters [174]

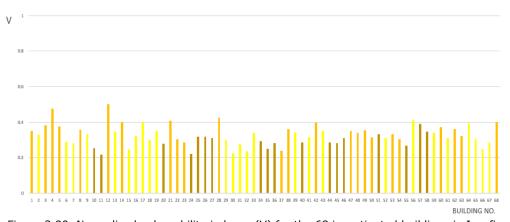
Figure 3.90. Normalized vulnerability indexes (V) for the 68 investigated buildings in Iosefin district, for all 15 parameters on the vulnerability form

Following the methodology for buildings in aggregate condition, there were obtained the normalized vulnerability indexes for each investigated building from losefin and Fabric historical areas. The indexes graphics for the buildings analysed in aggregate condition (all 15 parameters) are illustrated in Figure 3.90 for Iosefin historical district and in Figure 3.91 for Fabric area. As previously, brown colour is used for building typology type I, yellow represents type II, while orange means typology type III. The graphics highlight also a low to medium vulnerability index based on the applied methodology, but a bit higher than for the buildings considered as isolated.

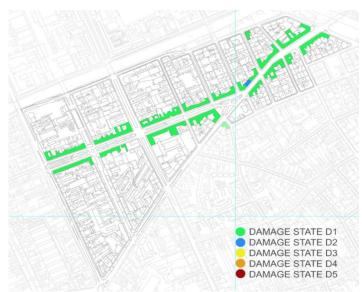
Figure 3.98. Seismic vulnerability map for Iosefin historical district, for all 15 parameters [174]

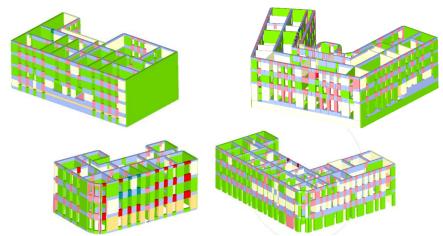
Figure 3.105. In-plane failure mechanism for some buildings from typological class type III, for both historical areas

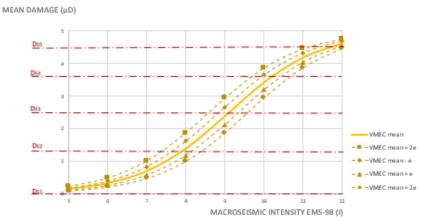
Figure 3.118. Proposed average mechanical vulnerability curve and vulnerability range for typological class type I, adapted for near-field earthquakes

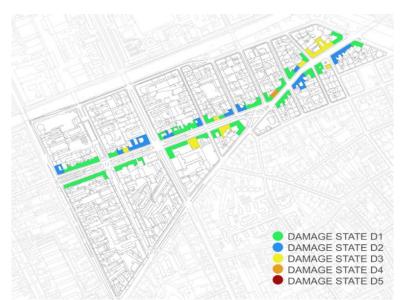
Figure 3.133. Seismic vulnerability map for Iosefin historical district, for first 10 parameters based on proposed adapted methodology [174]

There can be seen an increasing of the seismic vulnerability from typological class type I (damage states D1-D3) until the typological class type III (damage states D1-D4). There were designed also the vulnerability maps with the expected damage state for each investigated building, for both historical districts. The map for Iosefin district is presented in Figure 3.133, while the seismic vulnerability map for Fabric historical area is illustrated in Figure 3.134. The percentage of buildings that are expected to reach each damage state is detailed in Table 3.20.

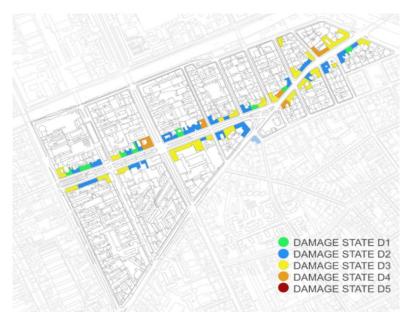
Figure 3.143. Seismic vulnerability map for Iosefin historical district, for all 15 parameters based on proposed adapted methodology [174]

For typological class type I the seismic vulnerability is moderate to low, with most probable damage state D2 and possible damage states D1-D3. For typological class type II, there can be seen a 10% increase of the vulnerability, the damage states ranging from D1 to even D4. When it comes to typological class type III, the seismic vulnerability increase even more, with another 20%, but without reaching damage state D5. The vulnerability maps illustrating the expected damage state for each investigated building are presented below for both historical districts. The map for losefin district is presented in Figure 3.143, while the seismic vulnerability map for Fabric historical area is illustrated in Figure 3.144. The percentage of buildings that are expected to reach each damage state is detailed in Table 3.21.

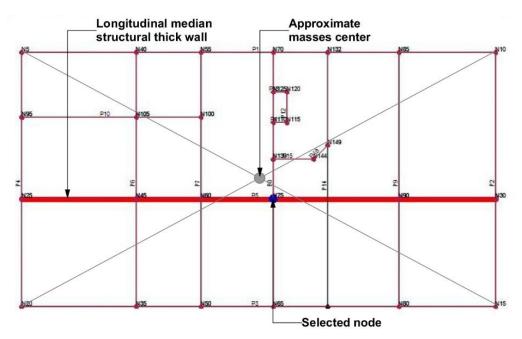
Figure 5.1. The position of the interstorey drift node in plan

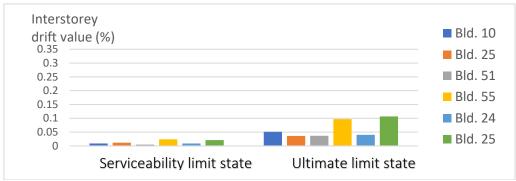
Figure 5.4. Interstorey drift value for buildings from the typological class type I

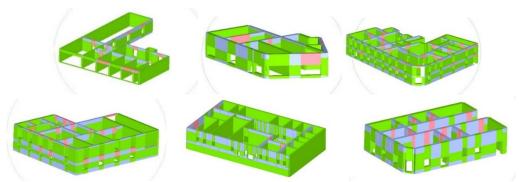
Figure 5.8. First damages registered for typological class Type I, for both historical areas

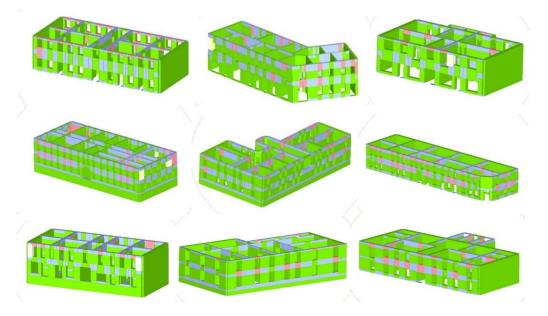
Figure 5.9. First damages registered for some buildings from typological class Type II, for both historical areas

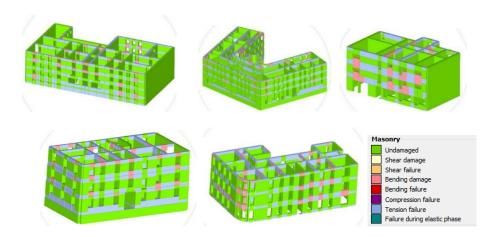
Figure 5.10. First damages registered for some buildings from typological class Type III, for both historical areas

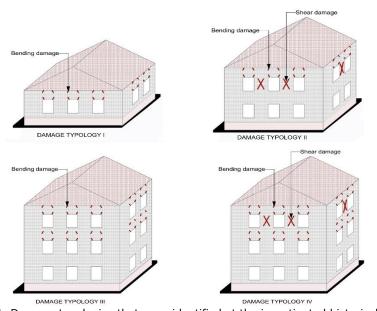
Figure 5.11. Damage typologies that were identified at the investigated historical masonry buildings

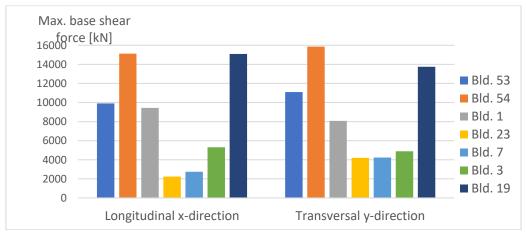
Figure 5.14. Maximum base shear forces for the investigated buildings from typological class Type III

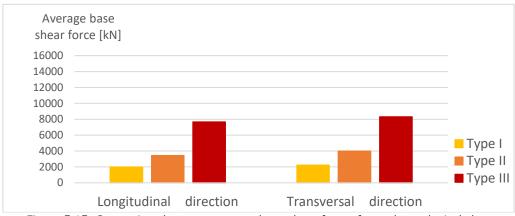
Figure 5.15. Comparison between average base shear forces for each typological class

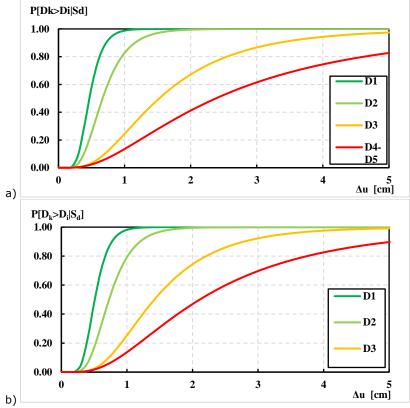
Figure 5.37. Average fragility curves for typological class Type III: a) for longitudinal OXdirection; b) for transversal OY-direction;

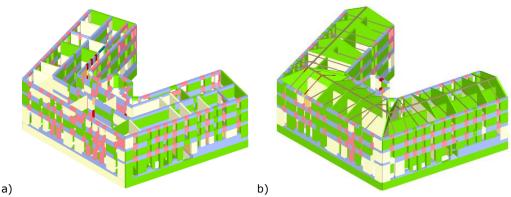
Figure 5.46. Mechanical model of Elite's Palace with damages in the limit state: a) without the roof; b) with the roof [252]
