SEISMIC RETROFIT OF PRECAST RC WALLS BY EXTERNALLY BONDED CFRP COMPOSITES

Teză destinată obținerii
titlului științific de doctor inginer
la
Universitatea "Politehnica" din Timișoara
în domeniul INGINERIE CIVILĂ
de către

ing. István DEMETER

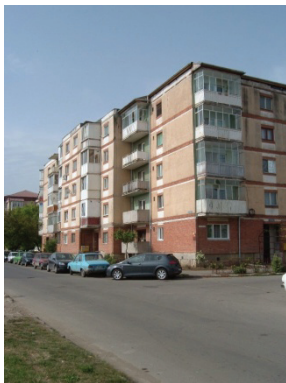
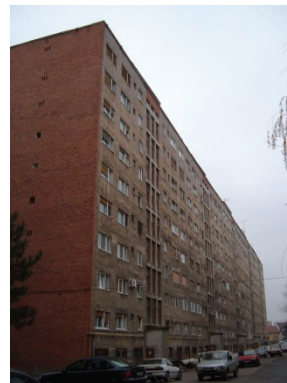
Figure 2.3 Inventory and construction period of RC flat blocks in Romania

A short overview of the history of large-panel structures in Romania was published by the author in [39]. The construction period of the large panel started in the early 1960-ies and gained wide application starting from 1970, see Figure 2.3. A landmark event was the Vrancea earthquake of March 4, 1977. This event marked the decline of 11-storey (P+10) but didn't affect the ascent of 5-storey (P+4) and induced the emerging of 9-storey (P+8). Post-1977 large-panel reinforcement was modified, see later in this. The 1970 to 1990 period can be referred to as the decades of P+4 large-panel low-rises, with more than 36000 buildings constructed. The 1989-1990 marked the end of large-panel in Romania.

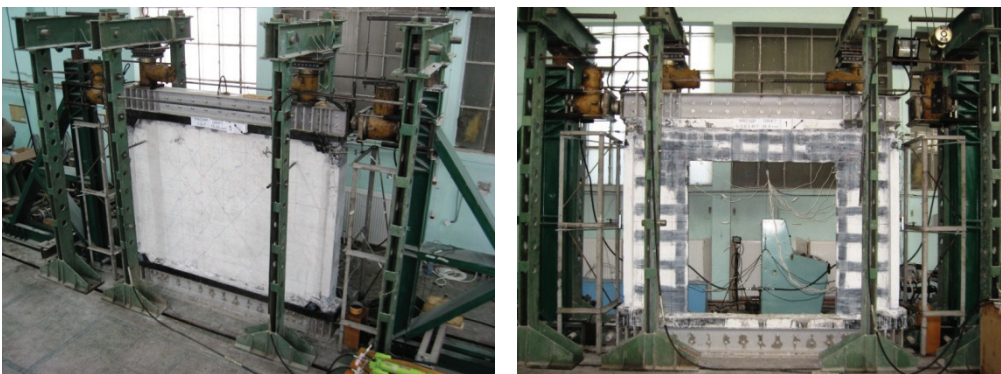
Figure 3.16 Test set-up

A general view of the test set-up assembled for the current experimental program is presented in Figure 3.16. Besides the wall specimen, the test set-up comprises two beams, four vertical reaction frames, two lateral reaction frames and the hydraulic equipment. According to the classifications described in section 2.3.5, this test set-up is an A-type with 4 loading degrees, suitable to achieve advanced cyclic loading for restrained rotation boundary conditions. Its singularity relies in the load transfer mechanism to model the outrigger effect deemed to be of primary importance in the real site seismic conditions. The performance characteristics of

the test set-up are 1000 kN cyclic horizontal loading at approx. 3 m height with ± 80 mm displacement that corresponds to approx. 4% drift ratio and two independently actuated (driven) vertical loads of 1000 kN each.

The specimens were set between two heavily reinforced steel concrete composite beams at the top and bottom parts referred to as cap and base beams, respectively. The cap beam served as load conveyor at the top of the specimen while its counterpart at the bottom served as foundation. These beams were especially designed and constructed for the experimental program and the same, except some minor modifications, pair of beams was used throughout the 7 tests. The concrete outlines and reinforcement arrangement for the loading beams are presented in Figure 3.17. In cross section, the loading beams were composed of two U300 steel channels and a reinforced concrete T-beam, connected by a series (42) of $\phi 20$ mm threaded tie rods. The concrete and reinforcing details were the same for both beams, except the presence of the starter bars in the base beam. Shear keys were formed according to the ones presented for the web panel horizontal edges and at the beam ends shear steps (outset) were provided.

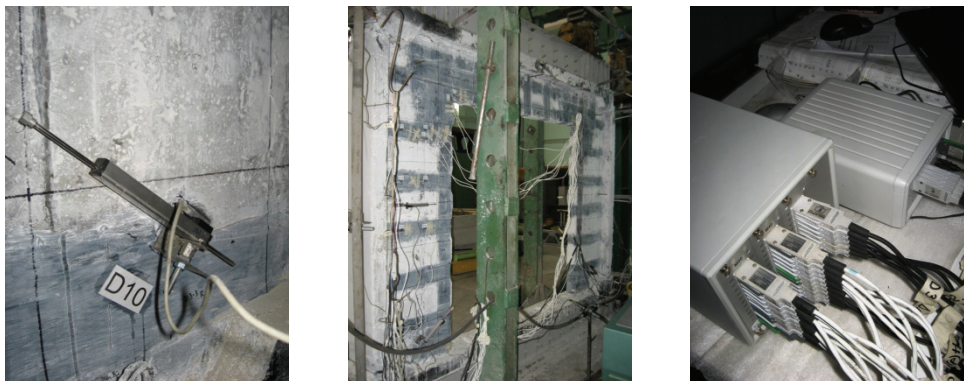
Figure 3.23 Instrumentation of the specimens

The behaviour of the specimens during the experimental tests was monitored by measuring three quantities, namely displacements, unit strains and forces. The main characteristics of the measuring devices (sensors) used are indicated in Table 3.16. The average number of measured values in each test was 10 displacements, 15 unit strains and 3 pressures. For data acquisition an Almemo 5990 system was used with 29 measuring inputs, see Figure 3.23. The generic layout of the displacement transducers and of the strain gauges is presented in Figure 3.23. A rear view of one of the specimens (6RT) shows the cable congestion (trajectories) conveying the recorded data to the acquisition system. The specific layout and detailed list of instrumentation for each test is given in Appendix C.

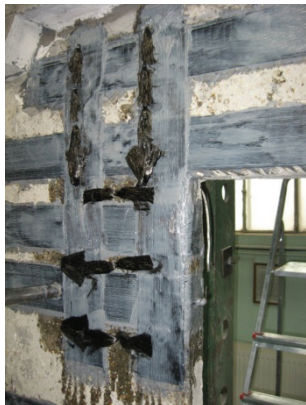
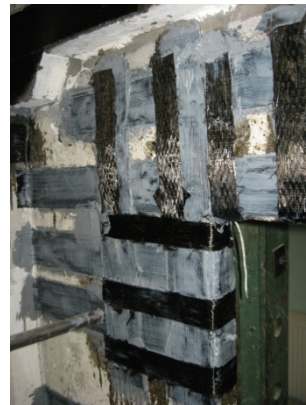
Figure B.5 FRP layout detail at the pier-to-beam connection of PRCWP 3-S/E1-T/R

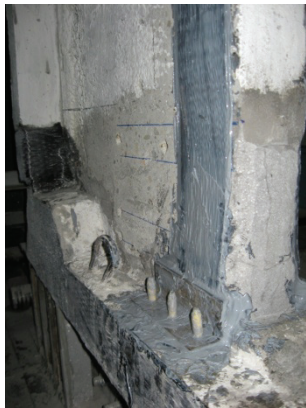
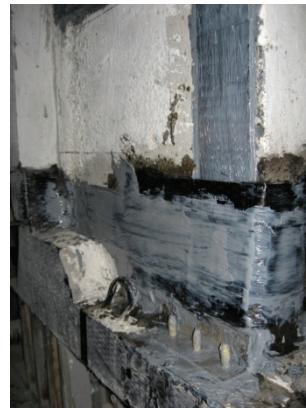
Figure B.6 FRP layout detail at the base anchorage of PRCWP 5-S/E3-T/R

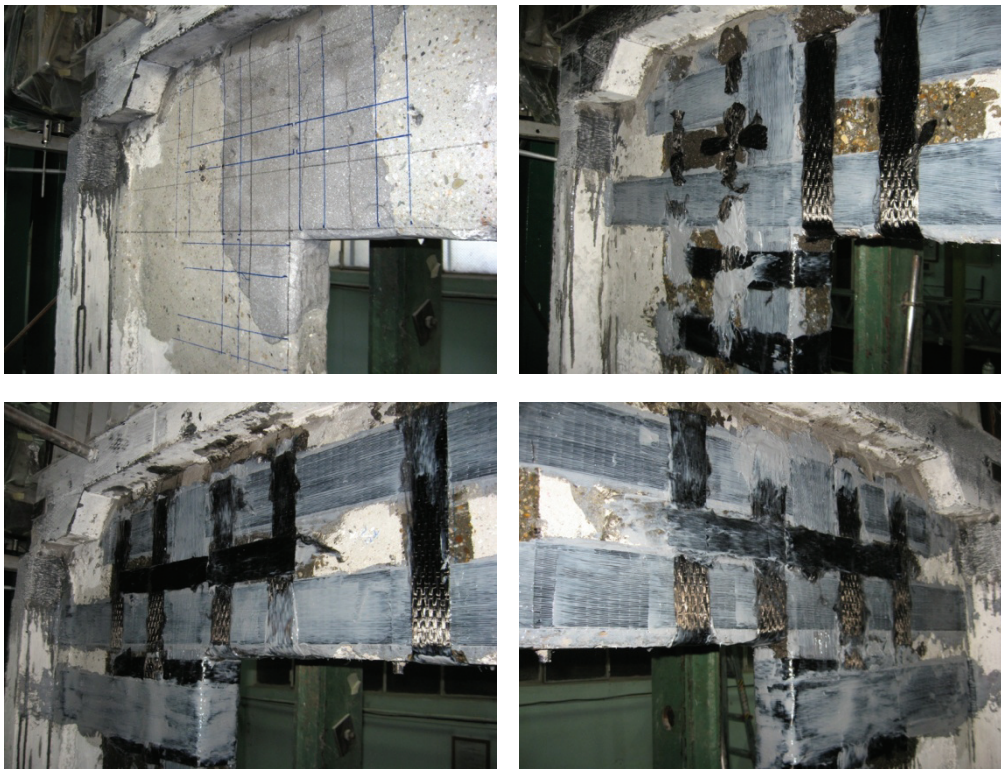
Figure B.7 FRP layout detail at the pier-to-beam connection of PRCWP 5-S/E3-T/R

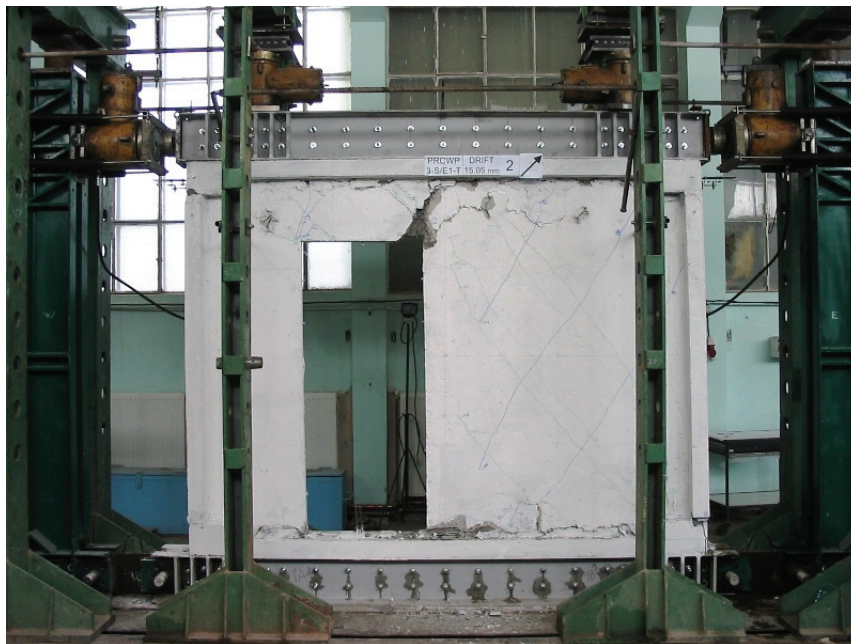
Figure E.18 Specimen PRCWP 3-S/E1-T at failure (0.7% drift ratio)

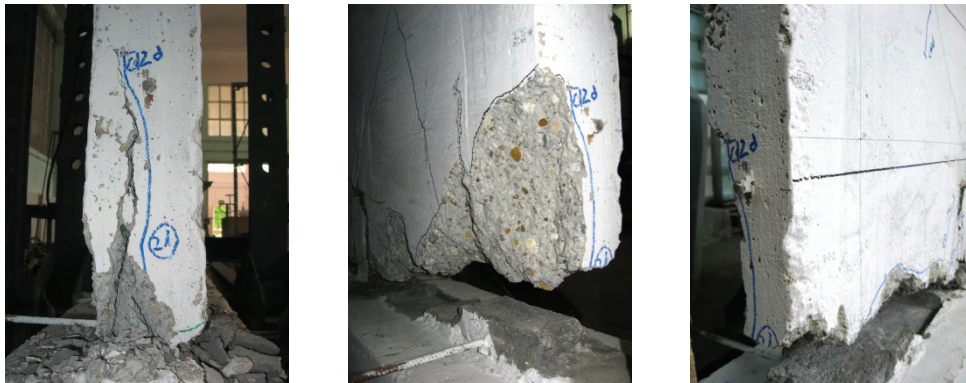
Figure E.30 Failure detail PRCWP 3-S/E1-T: concrete spalling and crushing at the inside toe of pier#2 (obs. grid 3-2)

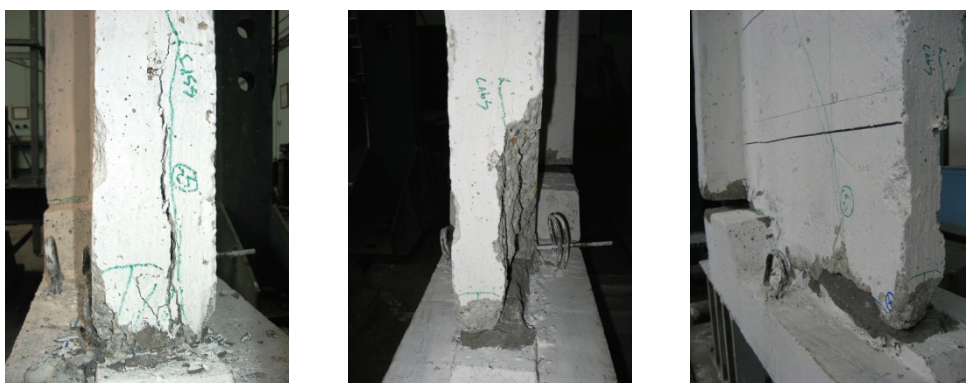
Figure E.31 Failure detail PRCWP 3-S/E1-T: concrete spalling and crushing at the inside toe of pier#1 (obs. grid 3-3)

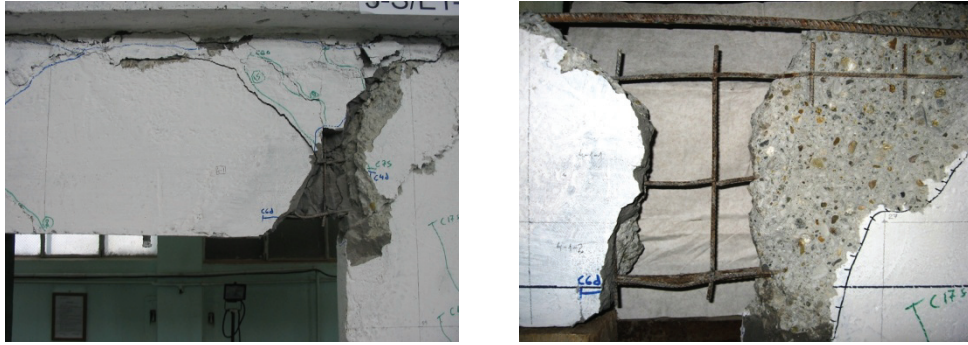
Figure E.32 Failure detail PRCWP 3-S/E1-T: concrete crushing at the spandrel-to pier#2 connection (close-up on grid 4-1)

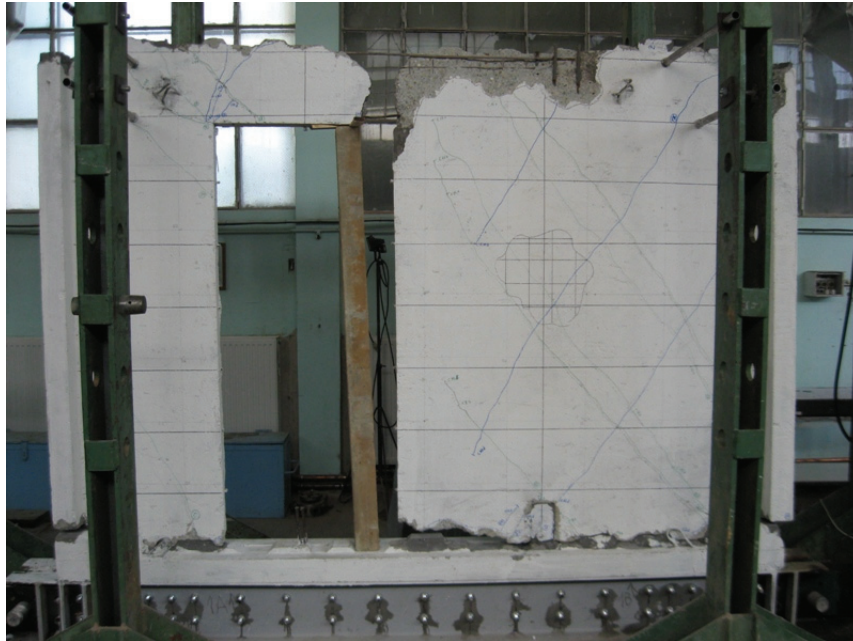
Figure E.33 Failure detail PRCWP 3-S/E1-T: general view after the crushed concrete was removed

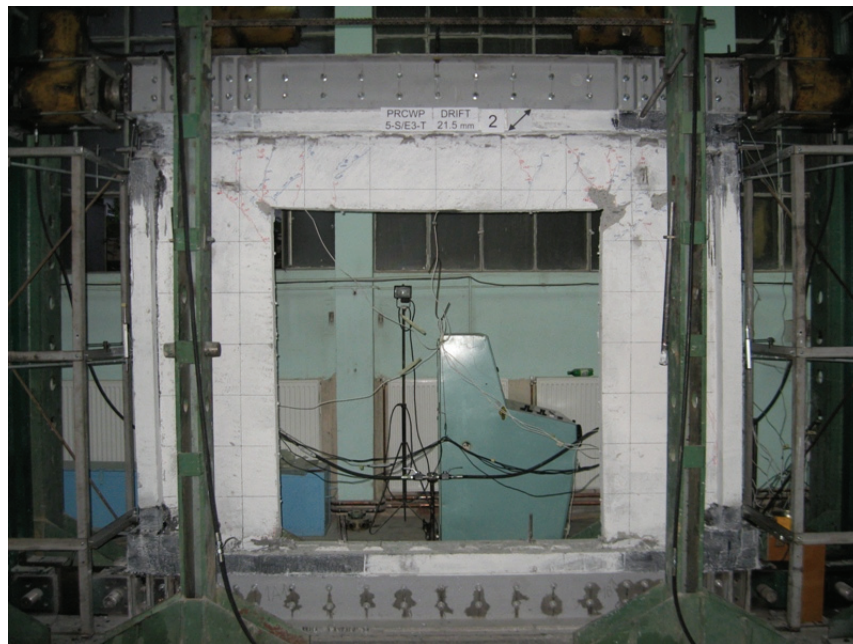
Figure E.34 Specimen PRCWP 5-S/E3-T at failure (1% drift ratio)

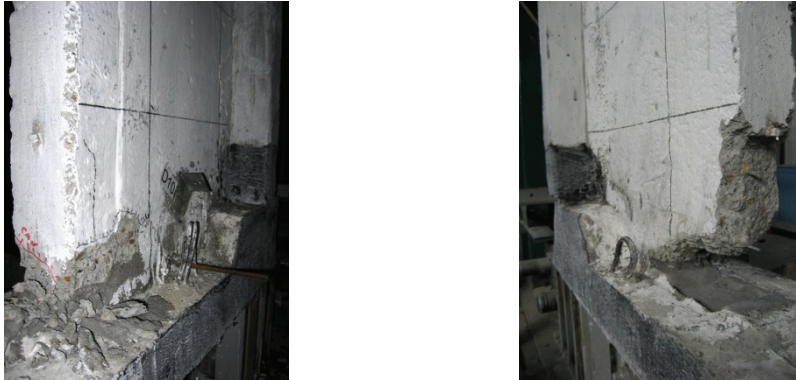
Figure E.51 Failure detail PRCWP 5-S/E3-T: concrete crushing at the inside toe of pier#1 (close-up on grid 3-3)

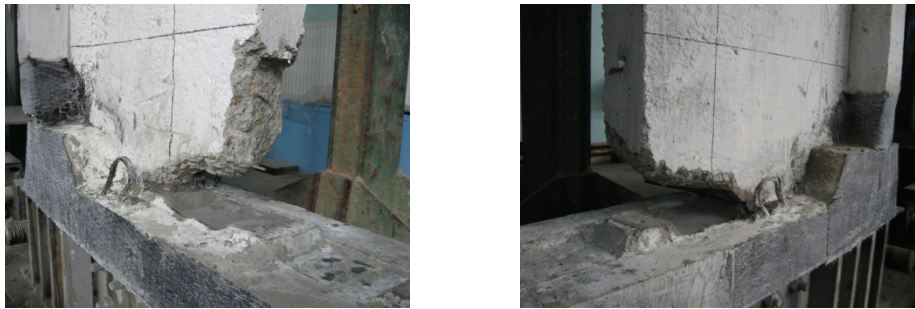
Figure E.52 Failure detail PRCWP 5-S/E3-T: the pier toes after crushed concrete was removed (close-up on observation grid 3-3 and 2-2)

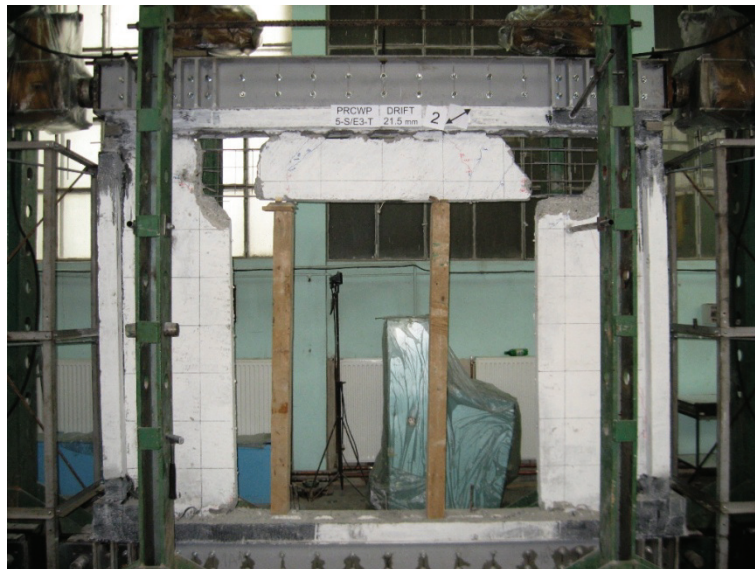
Figure E.53 Failure detail PRCWP 5-S/E3-T: general view after the crushed concrete was removed

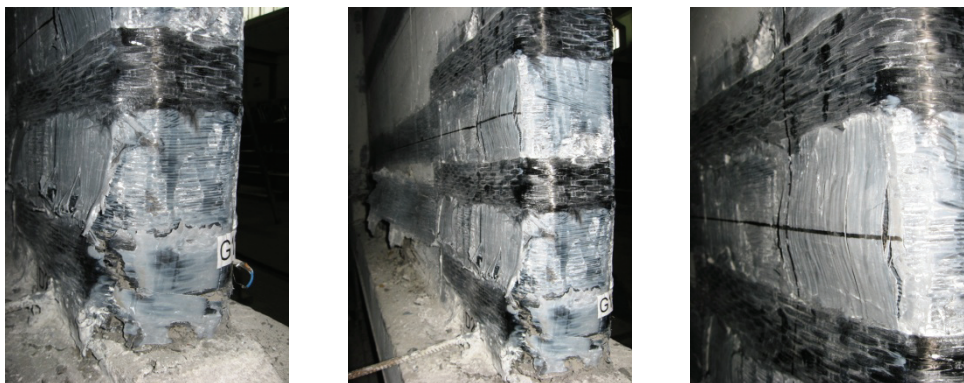
Figure E.71 Failure detail PRCWP 3-S/E1-T/R: bulging of vertical FRP at the toe of pier#2 (observation grid 3-2)

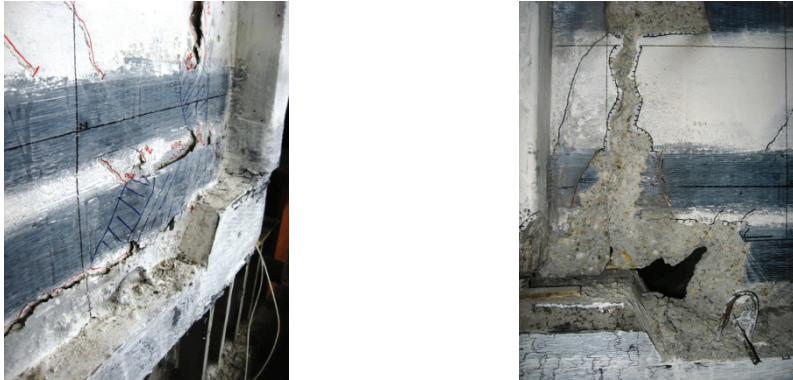
Figure E.72 Failure detail PRCWP 3-S/E1-T/R: FRP debonding and concrete crushing at the outside toe of pier#2 (observation grid 2-2)

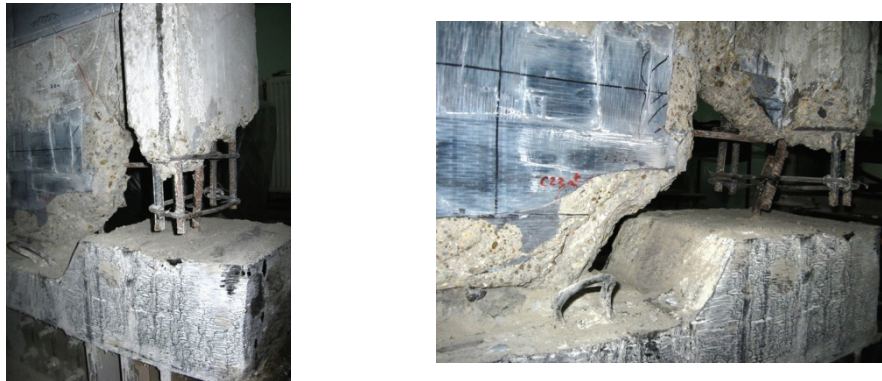
Figure E.90 Failure detail PRCWP 4-S/E1-R/T: the outside toe of pier#2 after removal of the crushed concrete (observation grid 2-2)

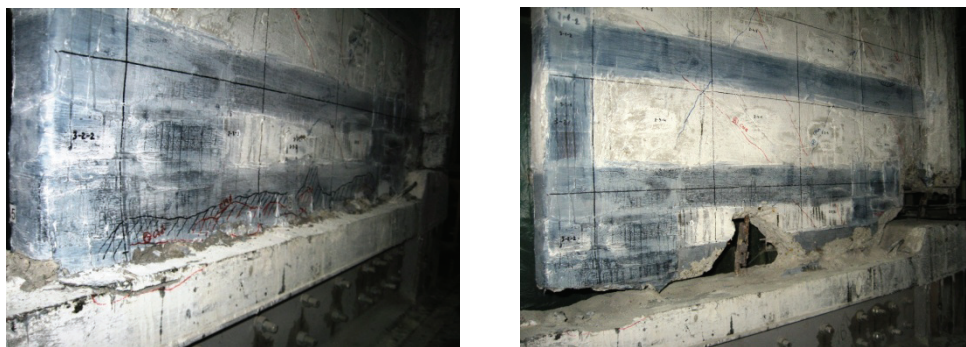
Figure E.91 Failure detail PRCWP 4-S/E1-R/T: the base of pier#2 at failure and after the crushed concrete was removed (obs. grids 3-2, 2-3, 2-2)

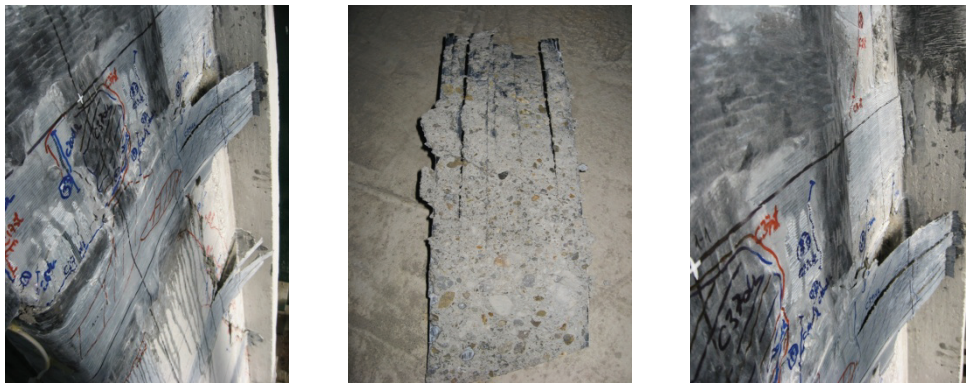
Figure E.117 Failure detail PRCWP 5-S/E3-T/R: FRP strip-end peeling-off at the pier#2-to-wing connection (obs. grid 1-1, 1-2)

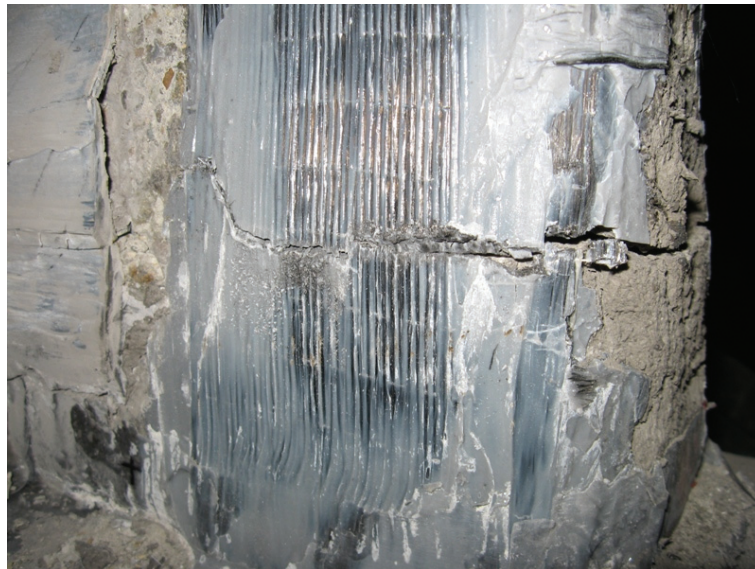
Figure E.120 Failure detail PRCWP 5-S/E3-T/R: the same failure is observed at the opposite face of pier#2 (obs grid 2-2 rear)

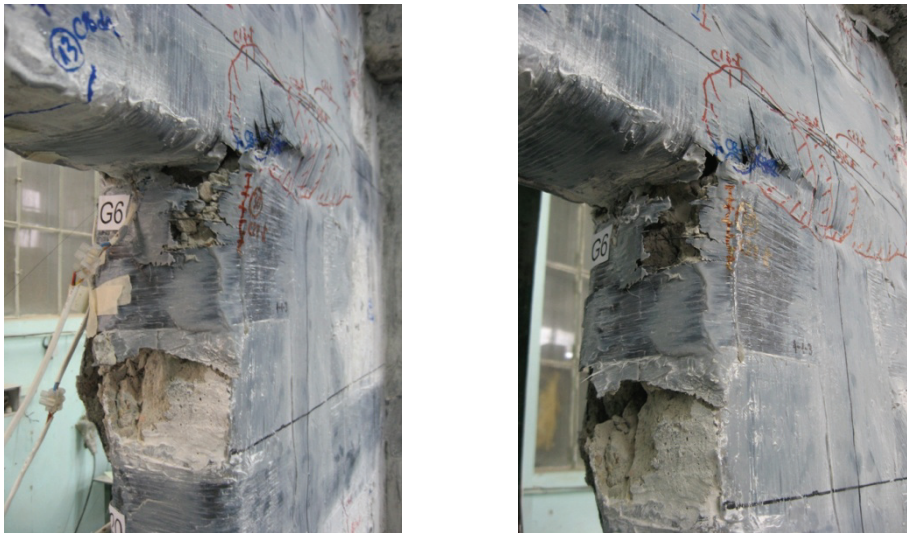
Figure E.144 Failure detail PRCWP 6-S/E3-R/T: FRP confinement fracture at the spandrel-to-pier#2 connection (obs. grid 1-1)

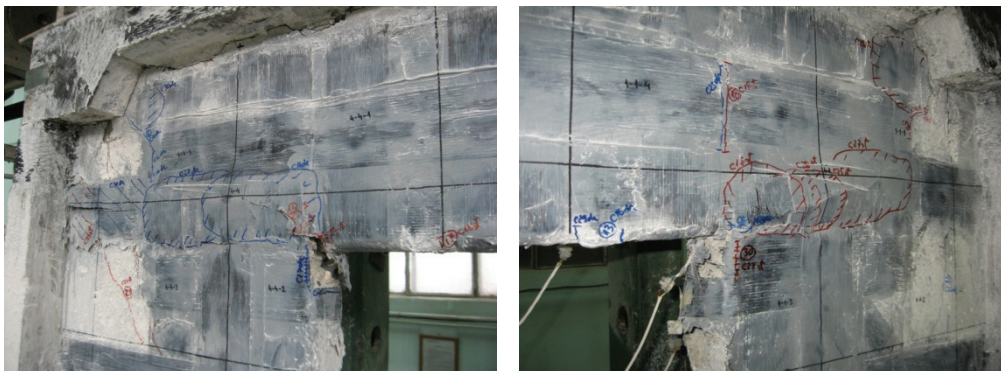
Figure E.145 Failure detail PRCWP 6-S/E3-R/T: FRP bulging and fracture at the spandrel to pier connections (obs. grids 4-4 and 1-1)
