Rehabilitation of Drainage Multipurpose Arrangement and Soil Erosion Control Greoni-Ticvani, Caras-Severin County

Abstract: Multipurpose arrangement of drainage and soil erosion control Greoni - Ticvani, Caras-Severin County executed during 1988-1989, after 30 years of work still needs rehabilitation. This paper presents the design situation before and after rehabilitation. Based on observations in the field (see photos) have been established and proposed rehabilitation works carried out in 2008 and presented photographs of section 2, works financed by the state budget.

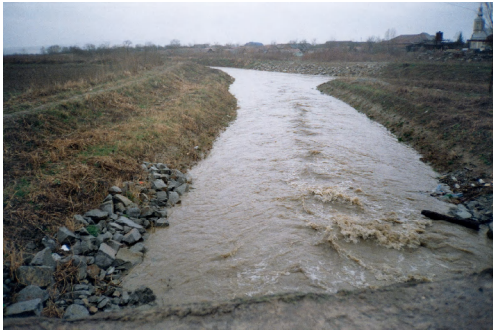
Photo 1 – Oravita Valley at the junction with Lisava Valley (2009)

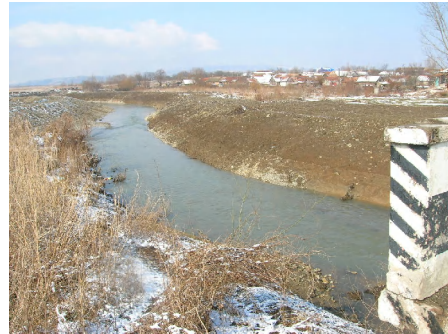
Photo 2 - Lisava Valley downstream of the DN 57 (2008)

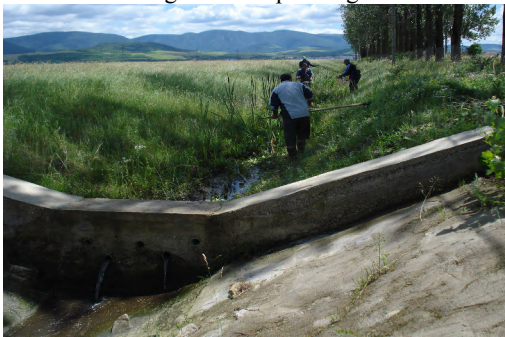
Photo 3 – Main drainage channel CP41 threshold drop of concrete, works for the destruction of aquatic vegetation and grassy (2010)

- herbaceous, water and wood vegetation destruction on the channels - handmade works and mechanical works by Stihl Motor mowers and chainsaws;

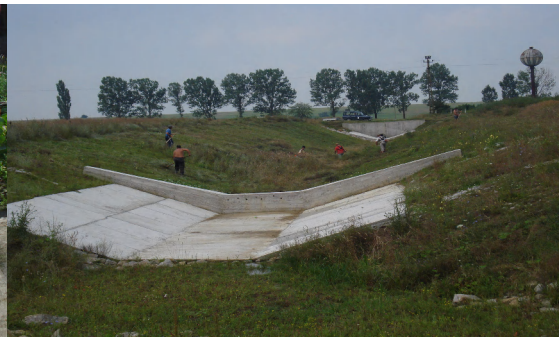
Photo 4 -Main drainage channel CP41 threshold drop of concrete, works for the destruction of aquatic vegetation and grassy (2010)

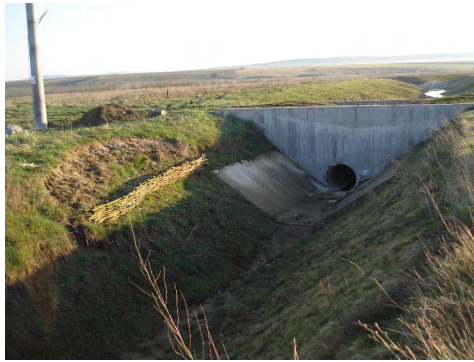
Photo 5 – Culvert pipe DN1000 on CCS43 Consolidation of slopes with fences of wattle (2010)

strengthening slopes of channels eroded by perennial herb - handmade works by leveling, raking

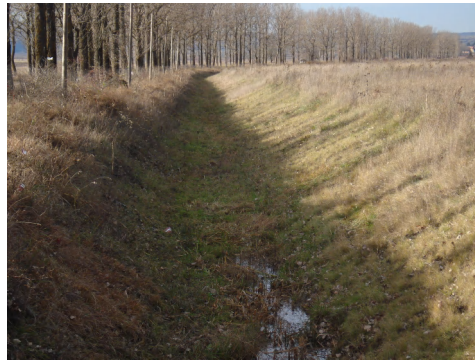
Photo 6 – Main drainage channel CP41 (2010)

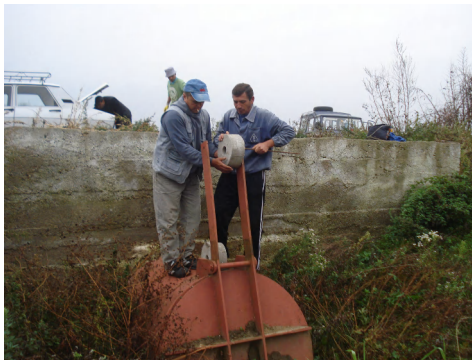
Photo 7 – Under-crossing the dike with metallic dampers Channel CCS42 Lisava Valley Maintenance and repairs works to the metallic damper counterweight (2010)

- maintenance of channels and hydraulic constructions (bridges, water drops, under-crossings the dikes with metallic dampers, etc.) - handmade works, consisting of cleaning mud in pipes and river

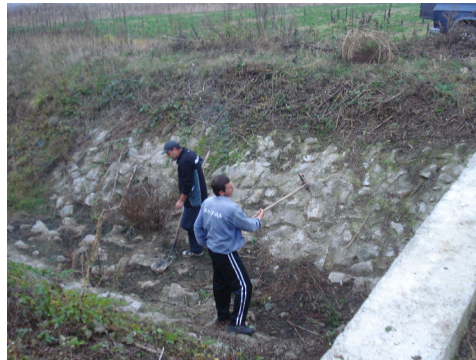
Photo 8 - Maintenance works on pipes at drainage channel CCS43 (2010)

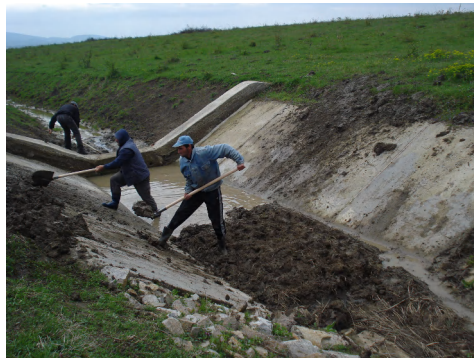
Photo 9 – Drainage channel CT4032 Cleaning works at the threshold drops (2009)

- release channels and hydro constructions - consisting of removing certain obstacles from

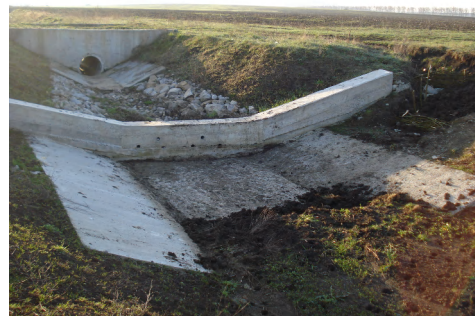
Photo 10 – Pipe culvert DN800 and threshold drop at drainage channel CS410 (2009)

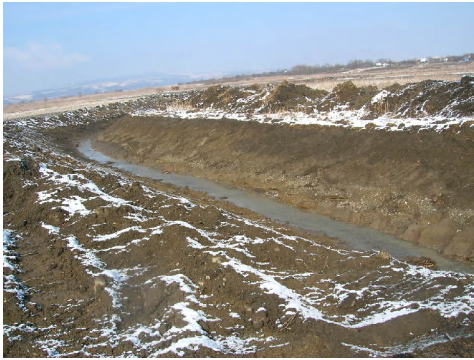
Photo 11 – Drainage channel CCS43 during execution (2008)

- 4 main drains: CCS41, CCS42, CCS43 and CS403, with a length of 10 250 m;

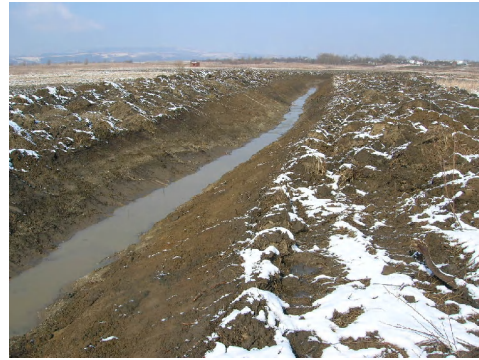
Photo 12 – Drainage channels CCS42 during execution (2008)

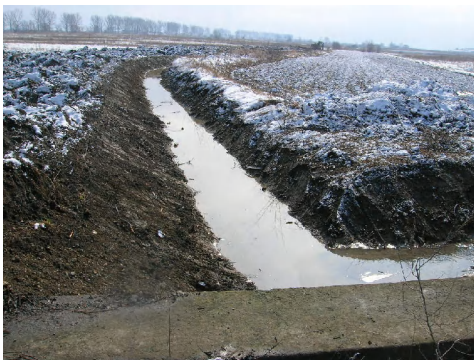
Photo 13 – Secondary drainage channel CT425 (2008)

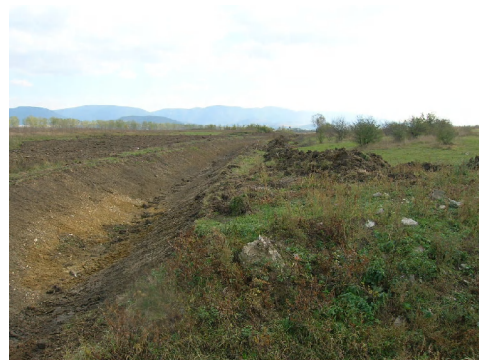
Photo 14 – Secondary drainage channel CT40321 (2008)

- 14 secondary channels: CT421, CT422, CT430, CS44, CT4034, CS4011, CS4010, CT4032, CT40321,

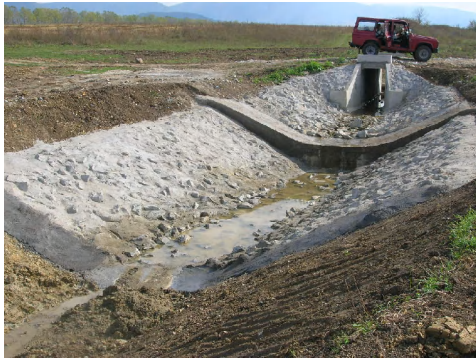
Photo 15 – Pipe DN1200 (of caissons) and drop of concrete and rough stone on drainage channel CS403 (2008)

- CT422, CS44, CS40, CS4011, CS4010 and CS405;
 - o 3 pipes culvert DN1000 on channels CCS42 and CCS41;
 - o 3 bridges DN1200, two bridges on the channel CS403 and a bridge on existing channel CP41, needed for equipment access to agricultural plots;

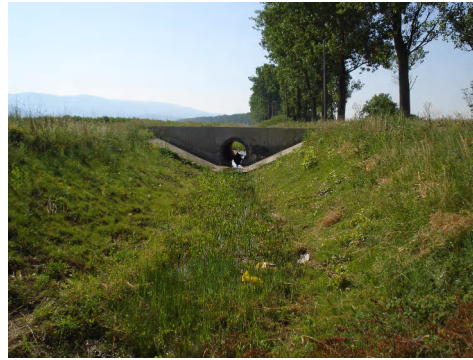
Photo 16 – Pipe DN1200 on drainage channel CP41 (2010)

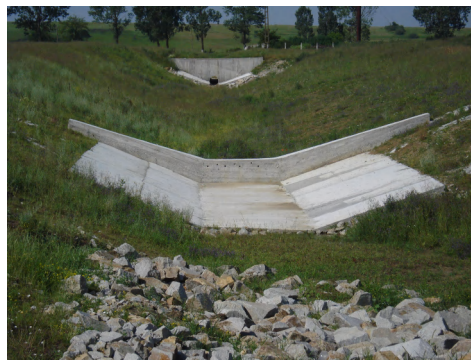
Photo 17 – Threshold drops, pipe DN1000 and consolidation at the junction with Lisava Valley of drainage channel CP41 (2010)

- 27 threshold drops with weep holes of concrete: 13 drops on channels CCS42, CS403,

- CT4032, CS410, 14 drops on existing channels CP41, CS207 and CS430 (Rachitova Valley 2);

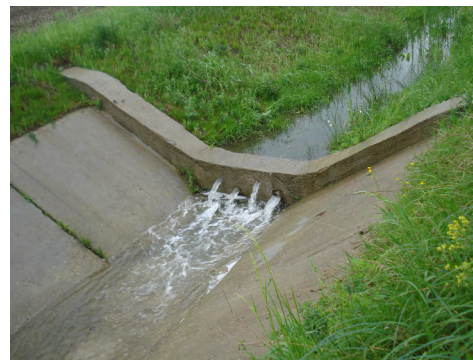
Photo 18 – Threshold drop of concrete on drainage channel CS403 (2010)

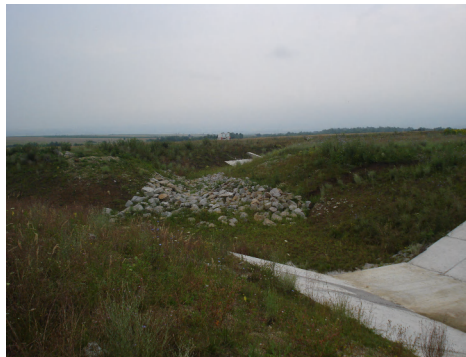
Photo 19 – Channel CP41 Consolidation with rough stone at the junction with channel CS410 (2010)

- 4 Consolidation at the confluence of channels

- CP41, CS410, CS207 and Lisava Valley;

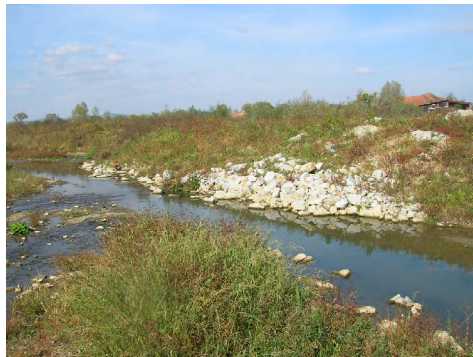
Photo 20 – Lisava Valley Consolidation with rough stone at the junction with cu Oravita Valley (2010) Oravita Valley and three Lisava Valley;

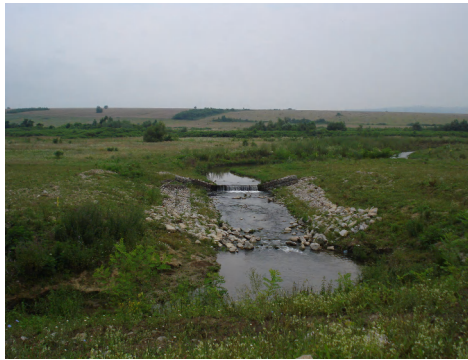
Photo 21 – Drop from gabions with rough stone on Lisava Valley at km 5+800 (2010)

- 4 drops of gabions, filled with stone, one on

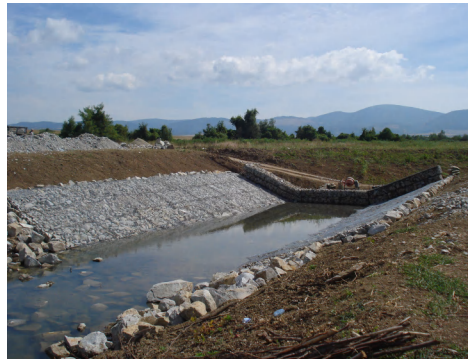
Photo 22 – Drop from gabions with rough stone on Lisava Valley at km 5+300 (2008)

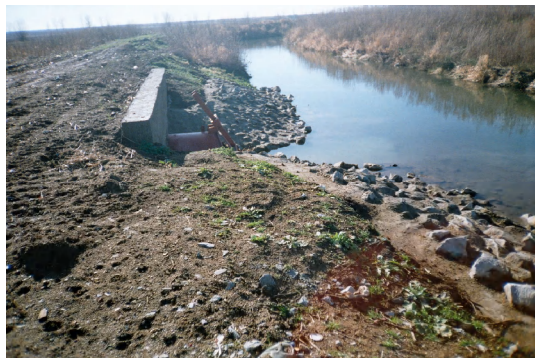
Photo 23 – Lisava Valley Under-crossing the dike with metallic damper on channel CCS42 (2008)

- 2 dike under-crossing, DN1000, metallic

dampers on channels CCS42 and CCS43 to escape in Lisava Valley.

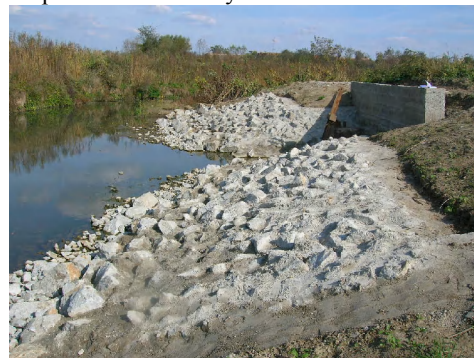
Photo 24 – Lisava Valley Under-crossing the dike with metallic damper on channel CCS43 (2008)
