Case of emergency effects due to meteorological phenomena in 10th of June 2012 and rectification solutions on DC 111 communal road, Pietroasa village, Timiș County

Abstract: This paper's aim is to present the negative effects of increased flow at Puștiul stream above the permissible limit near the Pietroasa village on communal road DC 111 near which it has its water course. DC 111 communal road crosses the Fărășești village and ensures the connection with DJ 684 B county road and is situated on the right shore of the Puștiul stream (branch of Bega River), which flows from Glodea mountain peak, to the mouth of the Bega River in Poieni. Also, the paper presents technical solutions recommended for removing disastrous effects produced by the flood and bringing communal road 111 to a corresponding state of viability. **Keywords:** stream, calamity, restoration, shore consolidation, state of viability.

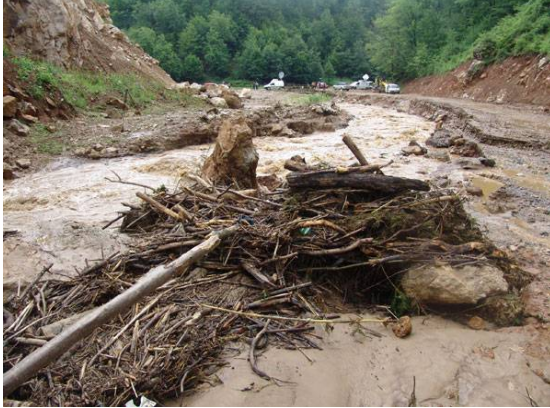
Figure 2.

Due to the rocky ground and narrow riverbed, the flood has broken the road body. The road has a sinuous routing and follows the creek stream, having the opportunity to increase its road territory due to delimitation by the water on one side and a rocky slope on the other side.

To assure the road stability and the carriageway width according to Romanian norms in force and to protect the road from possible floods, we recommend to protect the road with riverbank protection works, where circumstances so require.
