# Researches Regarding Soil Erosion and Measures to Fight it on the Declivitous Terrains Located in the Cornea Locality Perimeter Caraș-Severin County. Their Impact over the Locality

**Abstract:** In this paper are presented the erosion forms that led to the land slip from the Cornea locality, Caraș-Severin County, their impact over the locality and the resolution for the area improving.

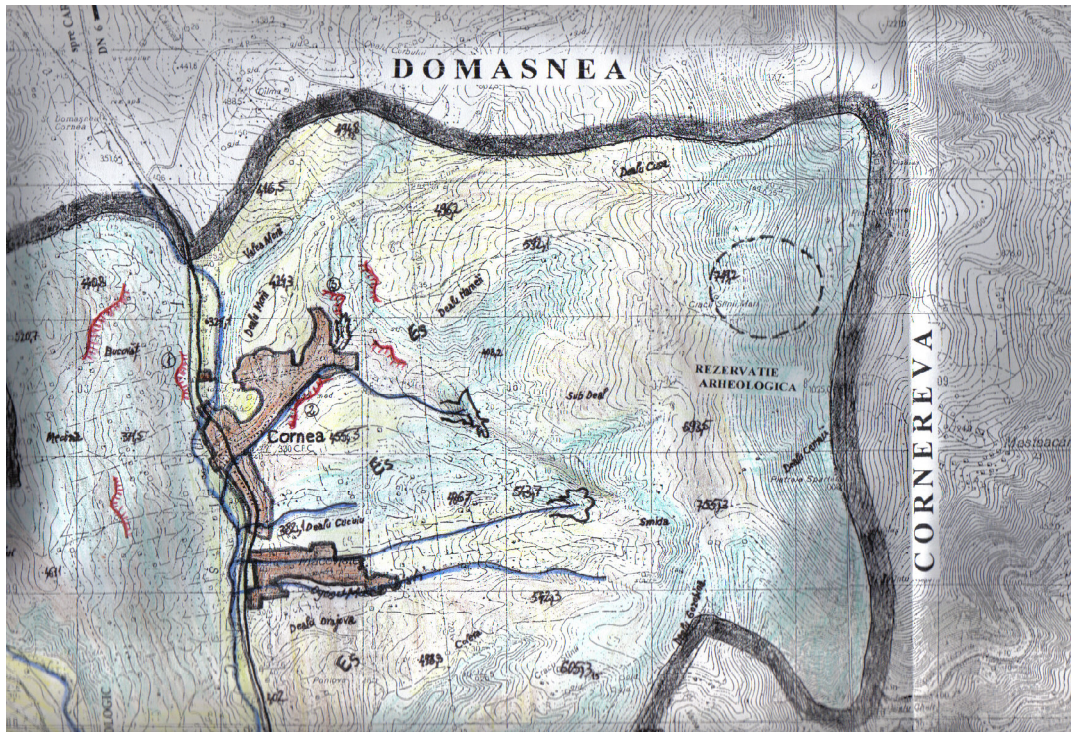
Fig. 1 The map of Cornea locality

To elaborate the research, that is the base for the present paper, the following data were used. We used the plan at 1:25000 scales (figure 1).

To elaborate the paper a lay-out plan was used with the scale 1:5000 and 1:25 000.

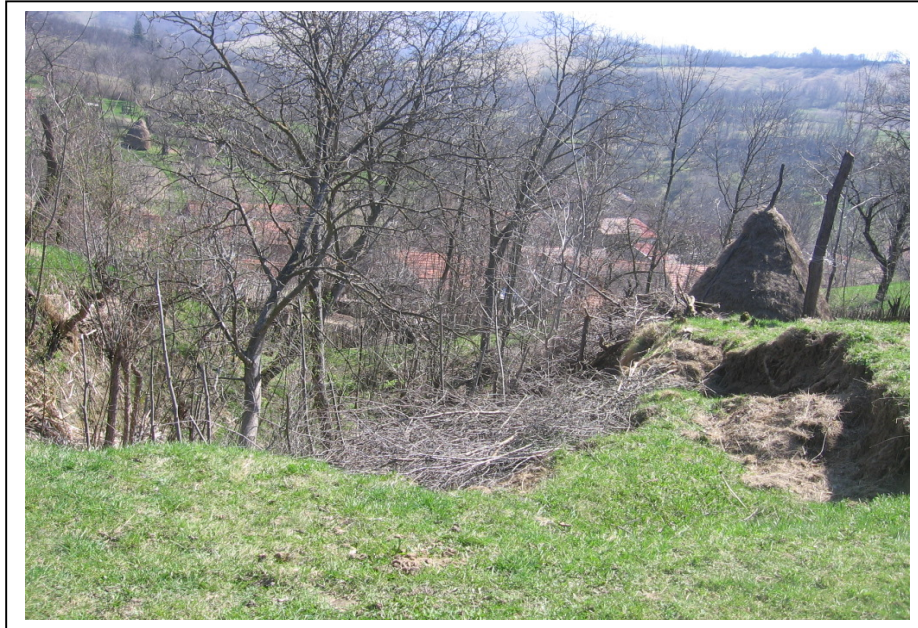
Fig. 2 The Cernilova land slip

- For the landslip (small depth and surface landslip), near “Cernilova” base flank we propose the next solution (figure 2):
  - To level away the slip surface
  - Execute a horizontal drain to the base of the slip, that will collected the water from the sandy horizon that are situated under the gliding claying horizon, and will ejected to the emissary situated at the flank base.
  - To level away the area above the slip (an area with micro-dislevelment and furrows from farm equipment circulation)
  - A declivous earth wall execution, which will collect the surface water and will eject in the natural outlet from around.

- The land slip from Cernilova affects the entire agrarian field, the house and communal road from the landfall basis;

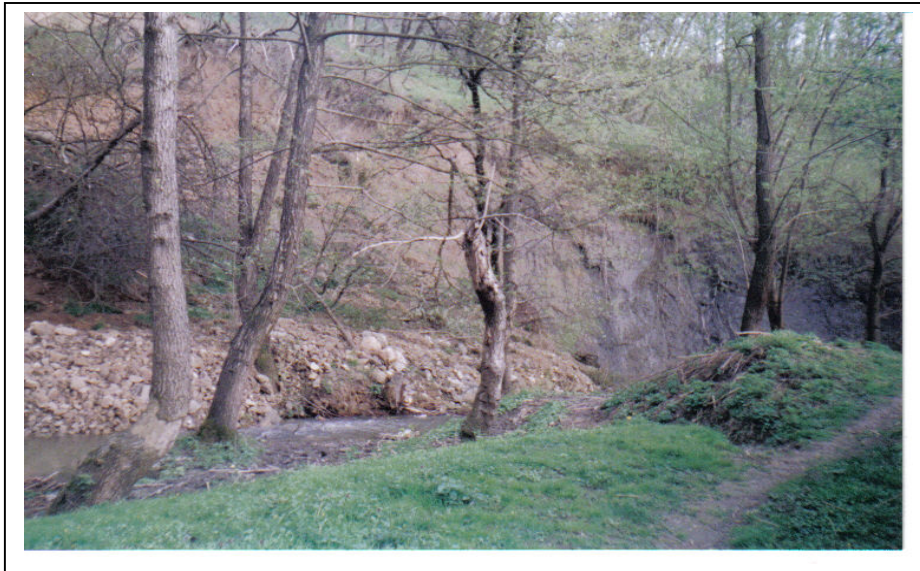
Fig. 3 The Cucuiului Hill land slip

- For the landslip situated in Cucuiului Hill we propose the next solution (figure 3):
  - Glen tip formation improvement, situated near the landslip, with an outlet collection channel form, that will undertake the surface water and will eject in “Chișăvăț” river.
  - A declivous earth wall execution, upon the landslip, that which conduct the surface water to this outlet.
  - Left bank consolidation of “Chișăvăț” River in the landslip area, by forest works, executing a tail board with 2 m height, for slope of thalweg modifying.
  -

- The land slip that currently affects the Cucuiului Hill may lead to major damages for the houses located at the base of the versant;

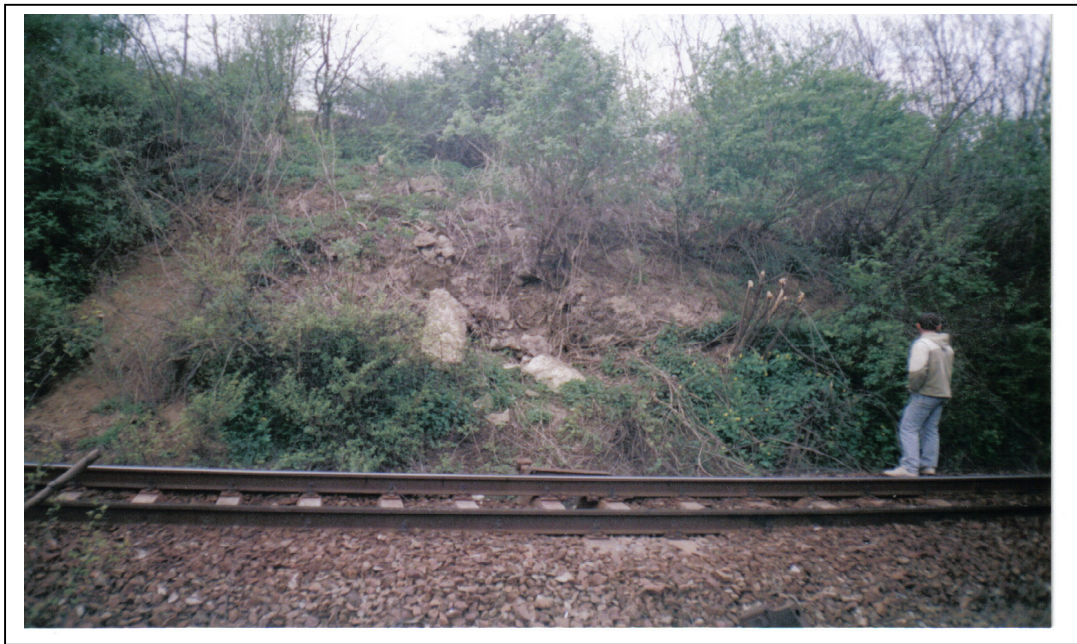
Fig. 4 The land slip near the rail road.

- For the landslip from figure 4, a landslip that affect the railroad that are situated at the base of the landslip we propose:
  - To execute an abutment from prefabricated pieces.

- The land slip near the veterinary dispensary affects the stability of the rail way at the base of the landfall.
