SEISMIC STRENGTHENING OF PRECAST RC WALL PANELS USING FRP COMPOSITES

Teză destinată obținerii
titlului științific de doctor inginer
la
Universitatea Politehnica Timișoara
în domeniul INGINERIE CIVILĂ
de către

Ing. Carla Toduț

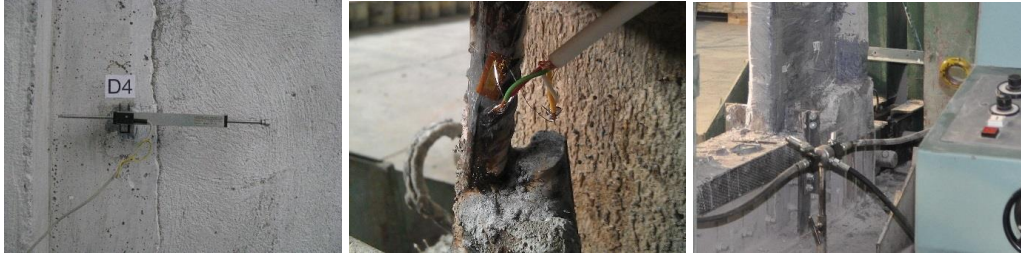
Figure 2.17 – Monitoring system

Piezo-resistive transducers were used to measure the pressure in three hoses of the hydraulic cylinders, namely one for the lateral loads and two for the axial loads. The resulted loads were obtained by multiplying the measured pressure with the piston area of the cylinders.

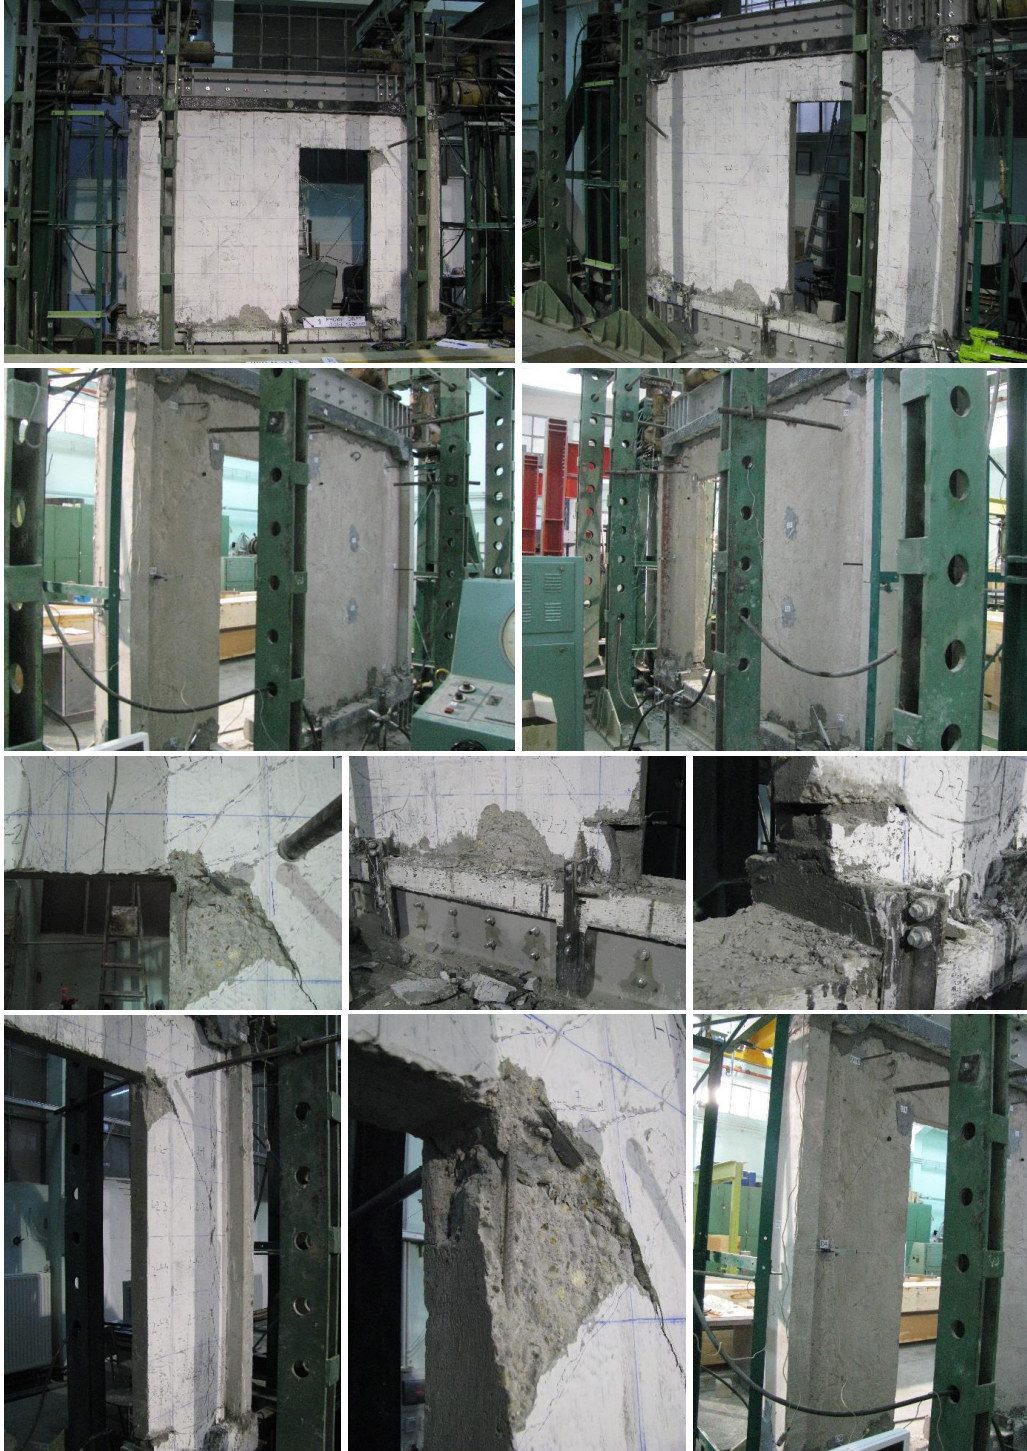
Figure 2.25 – PRCWP (12-E1-T) failure details [108-109]

PRCWP (12-E1-T) developed cracks in the spandrel, piers, wings, spandrel – pier connection region (near the opening), bottom extremities of the piers (near the opening) and cast-in-place mortar. The first inclined crack appeared in the right pier at 0.2 % drift ratio (4.3 mm), first cycle, and loaded from the left. Concrete crushing was observed in the spandrel – right pier connection region and the cast-in-place mortar at the bottom extremities of the wall piers, near the opening (see Figure 2.25).

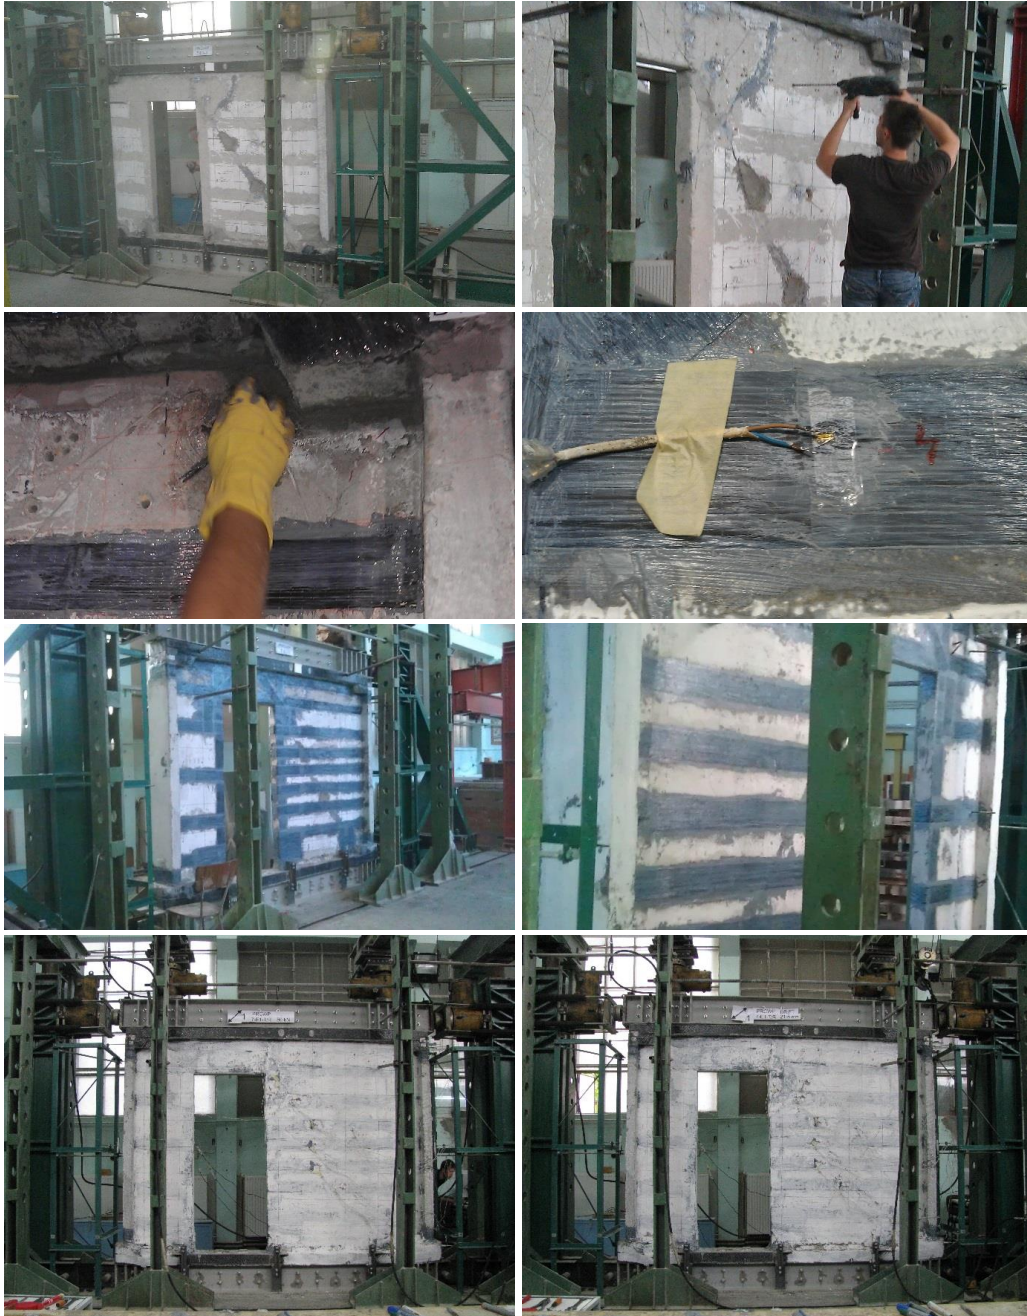
Figure 2.27 – FRP strengthening details

horizontally (f4) and vertically (f5) in the spandrel region. Short CFRP tows were used to anchor the bottom vertical sheets (f3, f6) to the foundation beam. Horizontal CF sheets (sh1, sh2) were applied on both piers, anchored at their ends by overlapping sheets on the door opening side (sh3) and by short CFRP tows at the wing-side end. Confinement was provided by CF sheets at the corners of the opening, namely the pier – spandrel connection region and bottom extremities of the piers on the opening side (c1, c2, c4), in the right pier (c3, c4) and at the ends of the wing walls (c5). The strengthening application details are given in Fig. 2.27. According to the adopted design philosophy, a more ductile behaviour for the rehabilitated specimen is expected instead of the brittle failure of the reference element.

In order to re-establish the seismic performance of the tested specimen, a design strengthening strategy was performed, based on EBR-CFRP (see Figure 2.26). For this, SikaWrap 230C unidirectional carbon fibre sheets of 100 mm width were applied symmetrically on both faces of the wall. The sheets were designated as flexural (f), shear (sh) and confinement (c) sheets, according to the strengthening objectives. In the application process, the CFRP sheets were placed parallel to the tension forces for flexural strengthening, parallel to the shear forces for shear strengthening and perpendicular to the compression forces for confinement.

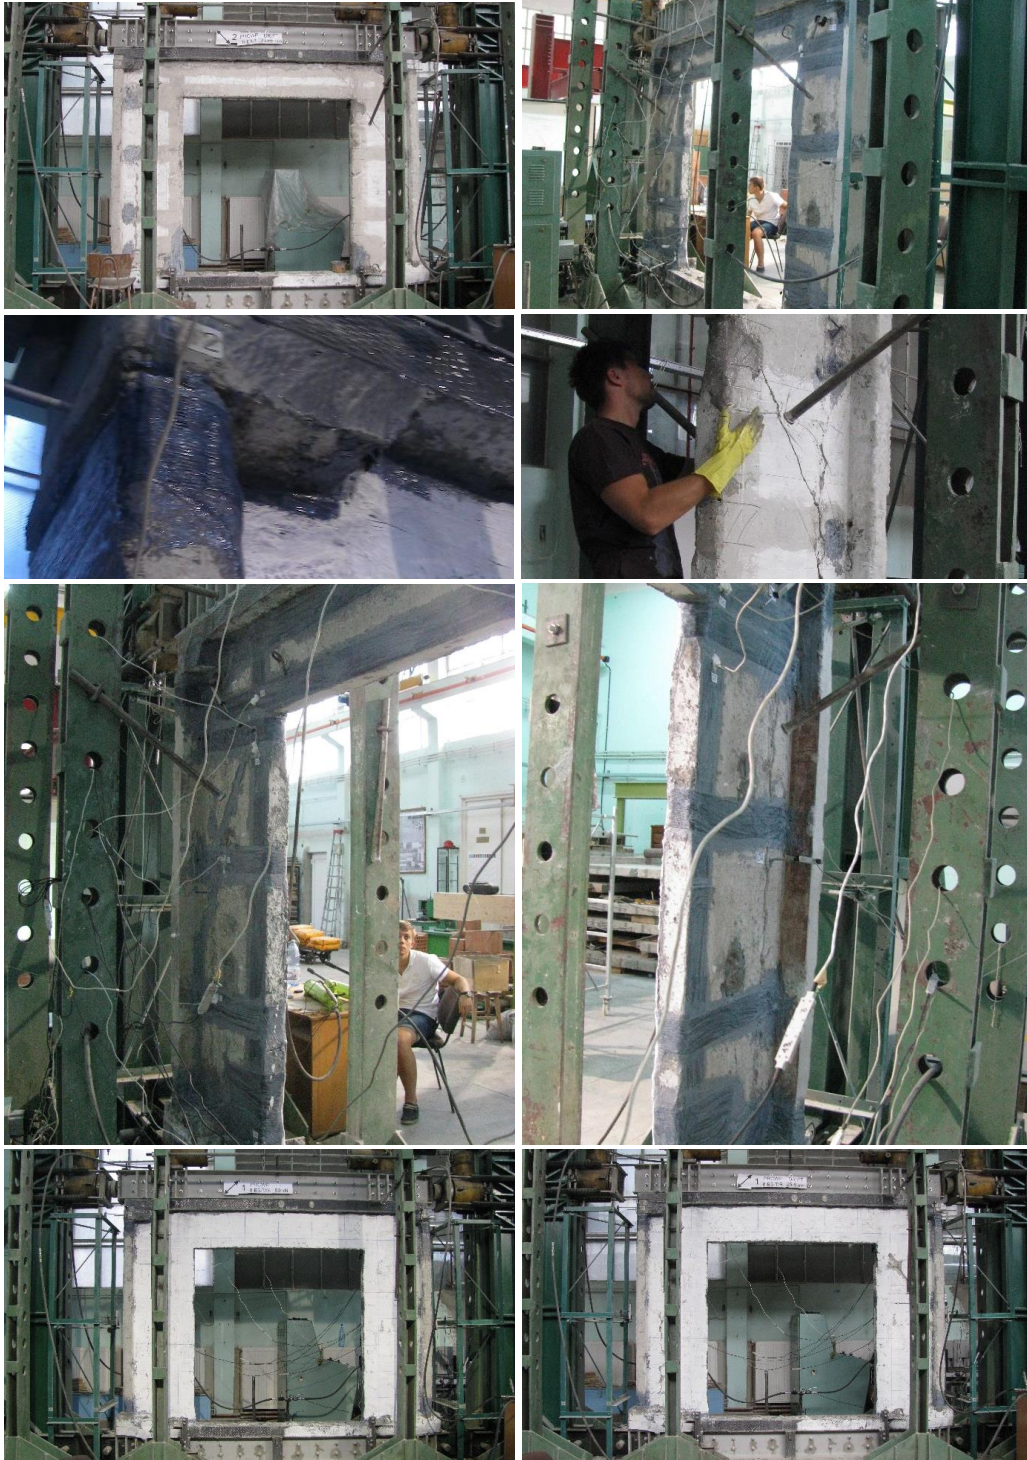
Figure 2.29 – FRP strengthening details

Following the idea in the previous rehabilitation strategy, similar design was performed for the specimen with as-built wide door opening (see Figure 2.28). Unidirectional carbon fibre sheets (SikaWrap 230C) were applied vertical along the door opening (f3) and horizontally along the spandrel (f1, f6). Additional shorter sheets were applied horizontally (f2) and vertically (f4) in the spandrel region. Short CFRP tows were used to anchor the bottom vertical sheets (f3, f5) to the foundation beam. Horizontal CF sheets (sh1) were applied on both piers, wrapping from one face to the other, anchored by short CFRP tows at the wing-side end. Confinement was provided by CF sheets at the bottom corners of the opening, namely the bottom extremities of the piers on the opening side (c1), and at the ends of the wing walls (c2). Considering the vertical crack that appeared between the right pier and the wing during the experimental test of the unstrengthened specimen, c3 confinement was provided. C3 sheet was used to tie back the connection between the web panel and the wing, wrapping from one face of the pier, through the wing, to the other face of the pier. The strengthening details are given in Figure 2.29.

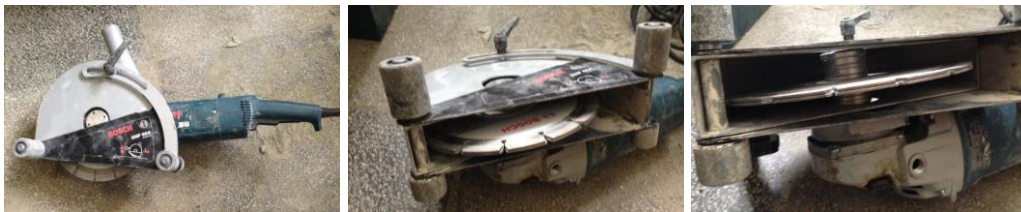
Figure 2.32 – Double disc grinder used for the NSM channel cut

Due to the fact that the double disc grinder (Figure 2.32) used to cut the channels for the near-surface mounted reinforcement application had the thickness of 3 mm for one disc, it was not possible to obtain a smaller thickness than 6 mm for the groove. Additional horizontal strips (f7) were provided to assure the left anchorage of the top CFRP plates. Additionally, vertical strips were wrapped from one face of the spandrel to the other (hoops), taking into account the lack of the spatial steel reinforcement cage in the spandrel region corresponding to the cut-out. The strengthening details are given in Figure 2.33.

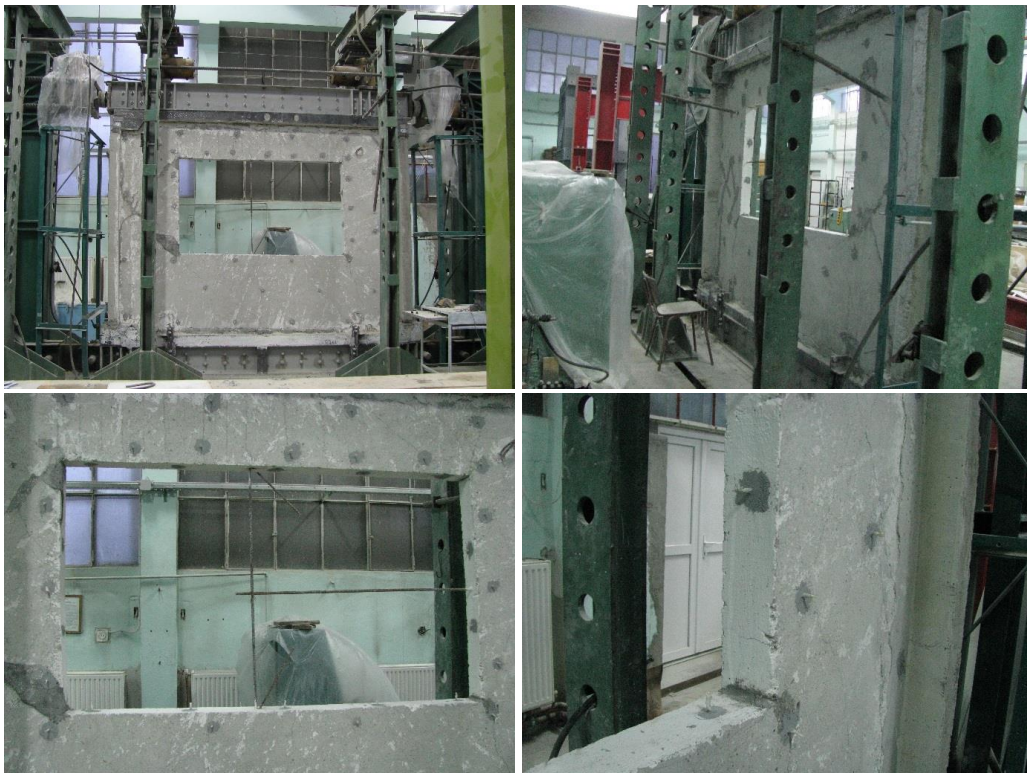
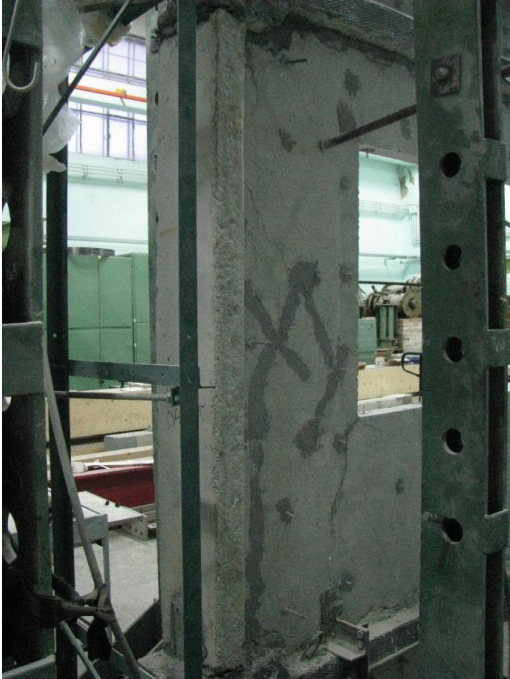
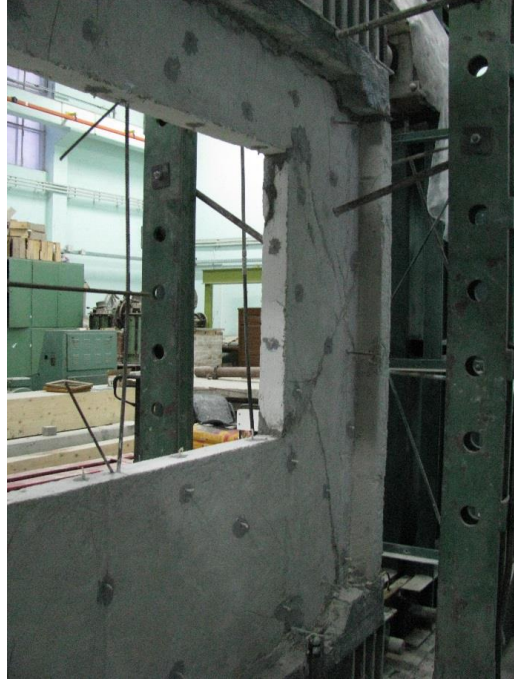
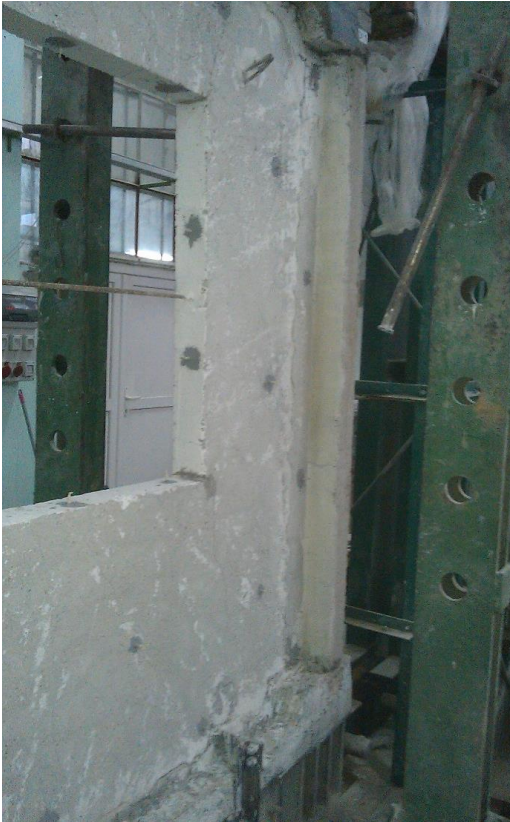
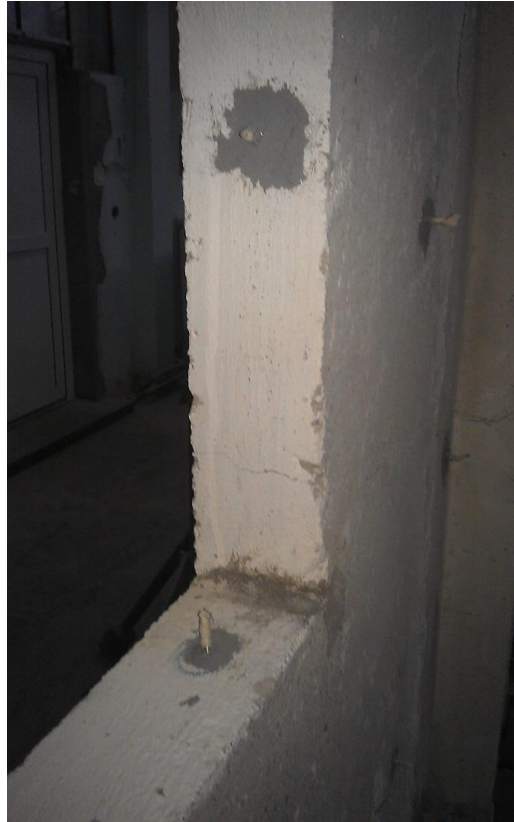
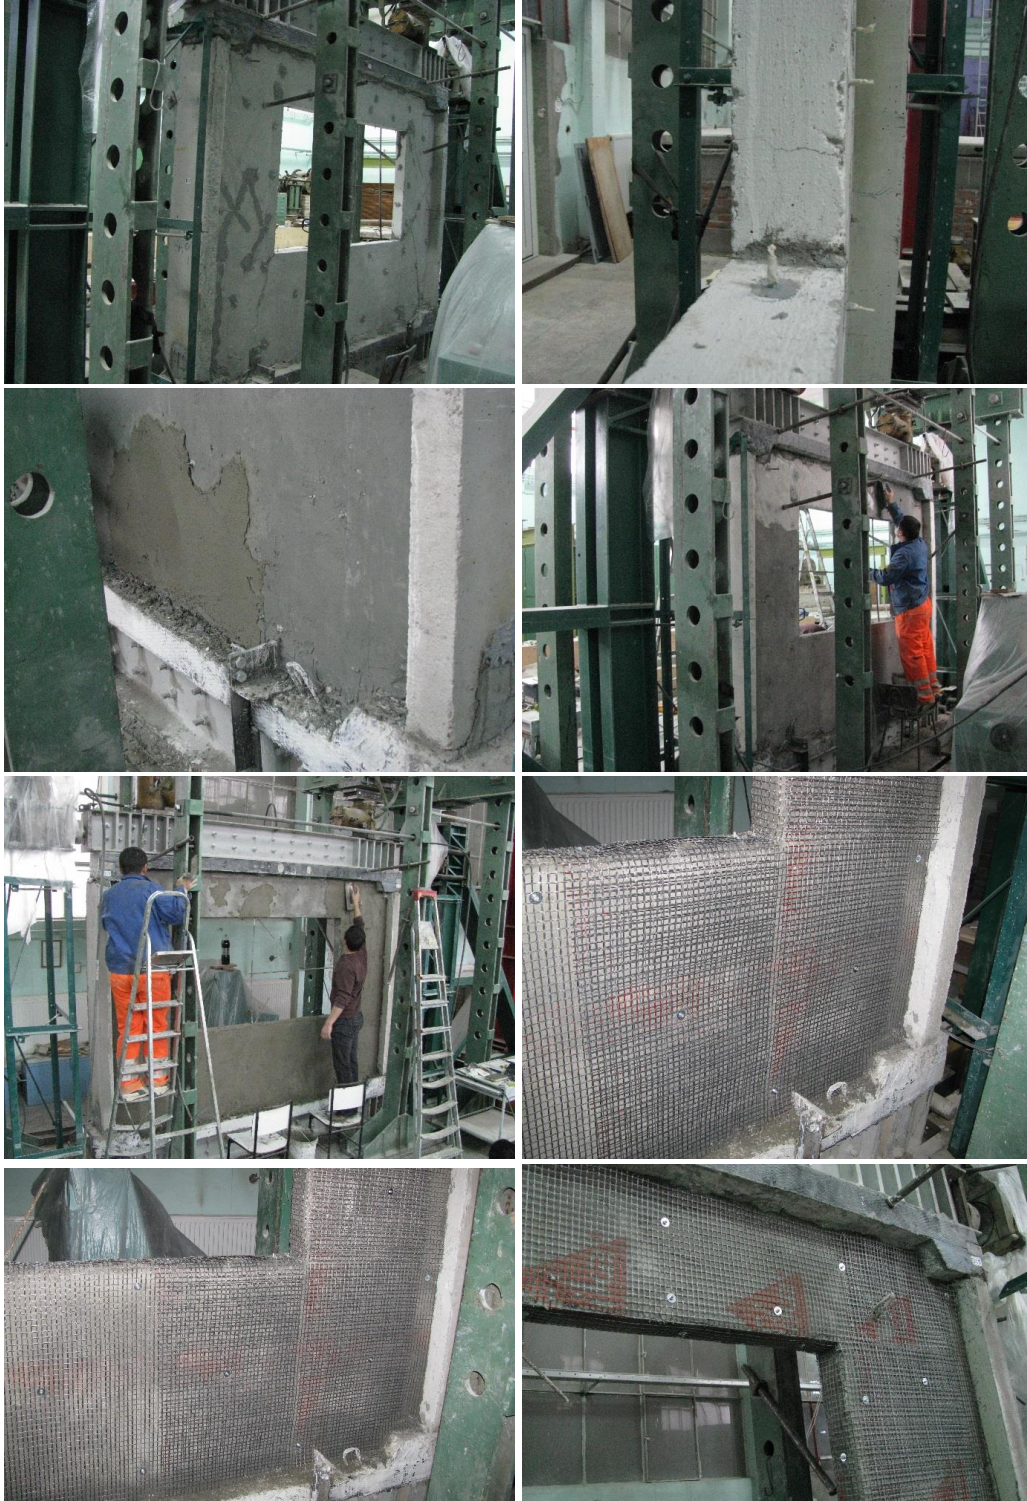
According to the design strategy, the grid pieces marked 4 on figure were first applied on each side of the parapet, followed by the number 5 grid pieces, which were also wrapped around the parapet. The grid pieces number 2 were applied on each side of the piers, followed by the number 3 grid pieces wrapping the piers on the opening side. Then, the grid piece marked 1 was wrapped around the coupling beam. The strengthening details are given in Figure 2.36.

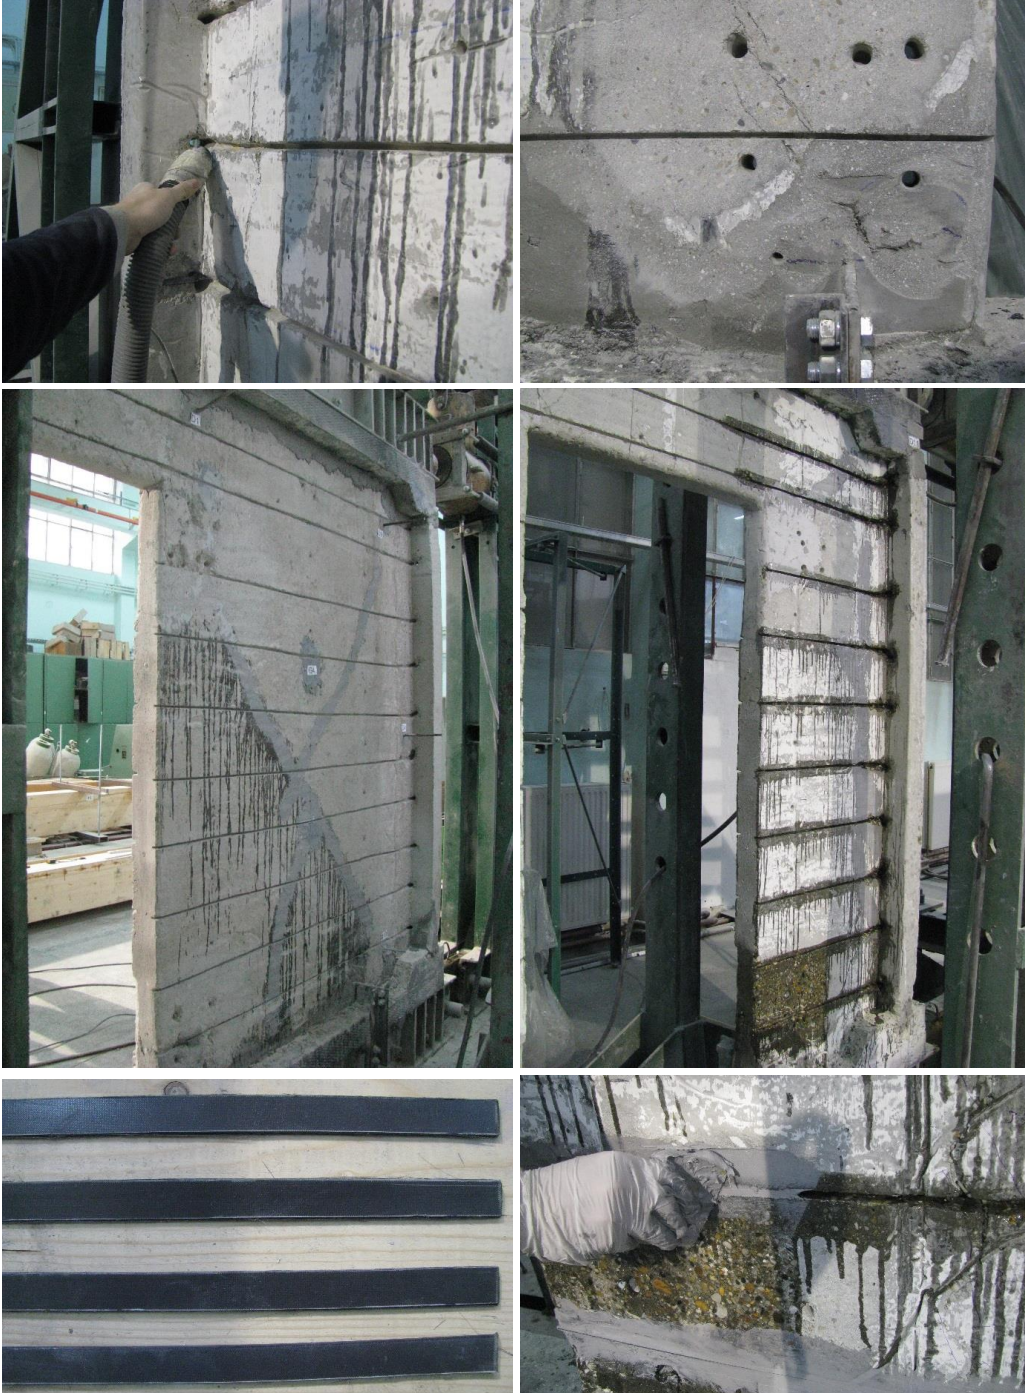
Figure 2.42 – FRP strengthening details

After the damaged specimen was repaired by replacing the crushed concrete with high-strength mortar, the surface of the wall was polished locally and the concrete edges of the specimen were rounded locally at a radius of about 20 mm. Holes were drilled in the wall panel for the FRP anchorage system, and then the surface of the wall was vacuum cleaned. In the strengthening process, NSM-CFRP plates (Carboplate E170/100/1.4) of 10 mm x 1.4 mm were fixed horizontally in the piers and in the spandrel on each side of the wall, at 200 mm centres, using epoxy resin (see Figure 2.40). All CFRP plates were anchored in the wing element. CFRP confinement strips (MapeWrap C UNI-Ax) were applied in the corners of the opening and vertical, wrapping from one face to the other of the spandrel, and at the ends of the wing walls (see Figure 2.41). The strengthening details are given in Figure 2.42.

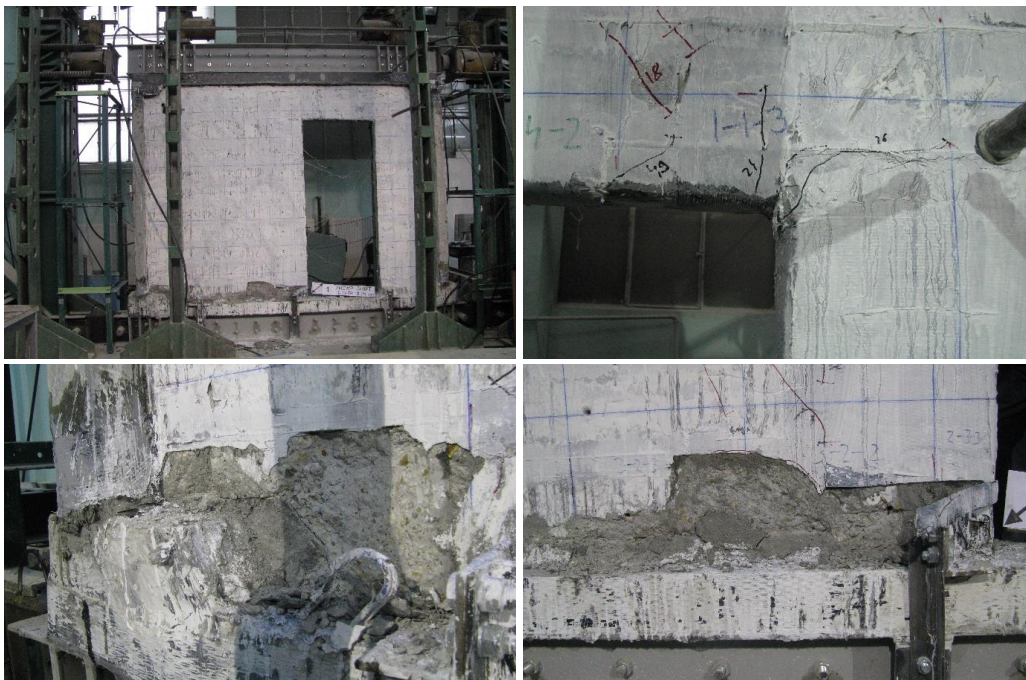
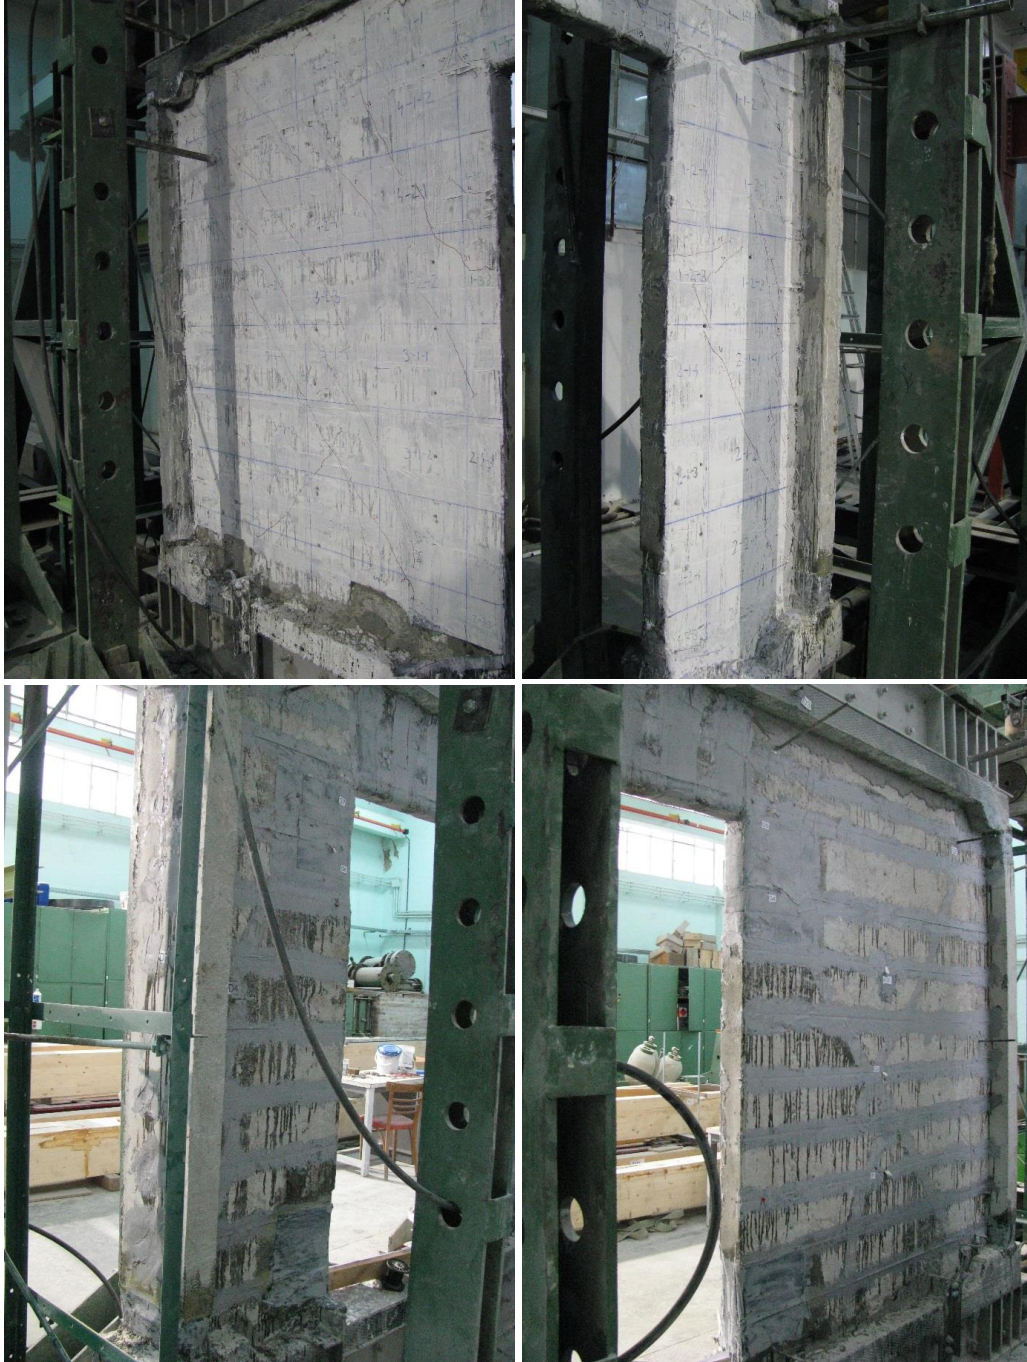
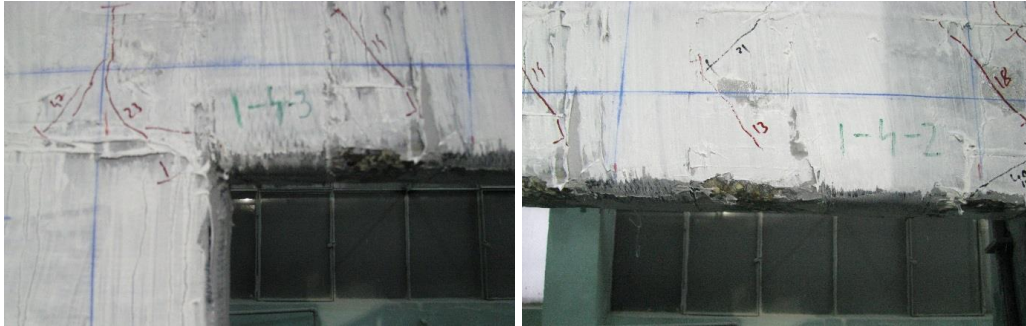
Figure 3.6 - Failure details of the PRCWP (12-E1-T/R) specimen [109, 120]

- PRCWP (12-E1-T/R): Cracks appeared in the piers, spandrel and spandrel – piers connection regions. Cast-in-place mortar crushed between the left pier and the foundation beam. C1 confinement sheet debonded and fractured at the bottom left corner of the opening. However, no failure of the CFRP plates was observed. The failure of the specimen was not attained during the experimental test due to the available capacity of the testing facility. Failure details of the PRCWP (12-E1-T/R) specimen are given in Figure 3.6.

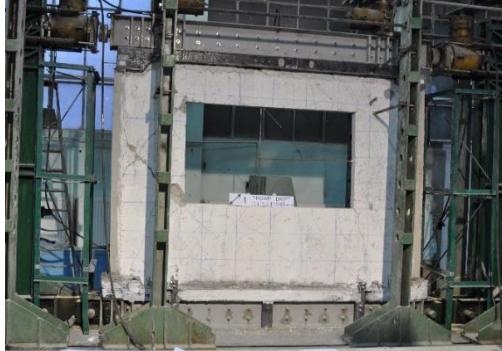
Figure 3.61 The final cracking pattern of the tested specimens

As observed in Figure 3.61, a significant number of flexural and shear cracks appeared during the experimental testing of the specimens. Flexural cracks appeared at the pier-to-reaction beams connection regions (mostly in the cast-in-place mortar). Few flexural cracks appeared along the piers' vertical edges (mostly between the web panel and unconfined wing) and in the spandrel beam. A significant number of inclined cracks can be seen in the piers, parapet and spandrel beam.

According to Appendix A, about 45 cracks were noticed during the experimental test of PRCWP (7-E1-T), 70 cracks for PRCWP (8-E3-T), 89 cracks for PRCWP (10-L1/L3-T), 79 for PRCWP (11-L1-T), 57 for PRCWP (12-E1-T), 16 for PRCWP (7-E1-T/R), 82 for PRCWP (8-E3-T/R), 57 for PRCWP (9-E1/E3-R/T), 115 for for PRCWP (10-L1/L3-T/R), 41 for for PRCWP (11-L1-T/R), and 49 for for PRCWP (12-E1-T/R).
