## SFRA Capability for detection of deformation in Transformer windings: A field experience of 400kV 167MVA single phase ICT

**Abstract** – Sweep Frequency Response Analysis has become very popular now – a - days due to its ability to provide comprehensive information regarding mechanical as well as electrical condition of power transformers. The SFRA is a signature test and provides better information when evaluation of Transformer condition is done by comparing actual set of SFRA results with reference results. This field experience refers to 400/220/33KV ICT bank, formed with three single phase units – each with capacity of 167MVA. Heavy fault current was fed through ICT due to failure of LA provided on external delta formation of Tertiary winding. Mechanical defects / deformation occur ostensibly due to short circuit current flowing through transformer winding in case of terminal faults i.e. fault adjacent to / on the power transformer. To ascertain mechanical integrity of power transformer, SFRA test is carried out and is supported by other tests i.e. capacitance and tan delta measurement etc. The test results reveal that SFRA is capable of providing more information about me

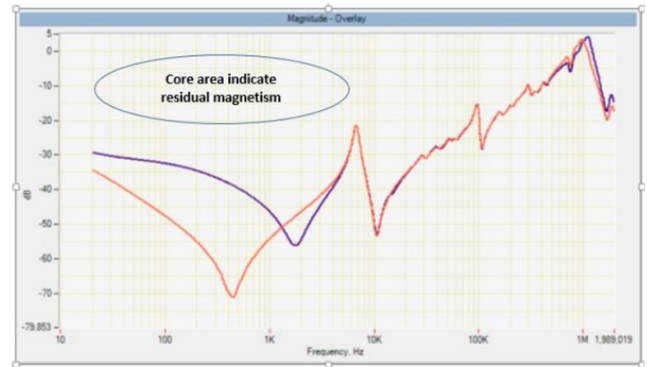
HV winding, and it may be due to residual magnetism. SFRA of tertiary winding also done and compared with base results - similar deviation noticed in SFRA traces of tertiary winding. Residual magnetism might have originated during fault condition. Effect of residual magnetism in LV and tertiary winding is shown in figure 5 and 6

**Fig. 5.** SFRA of L.V. comparison with base

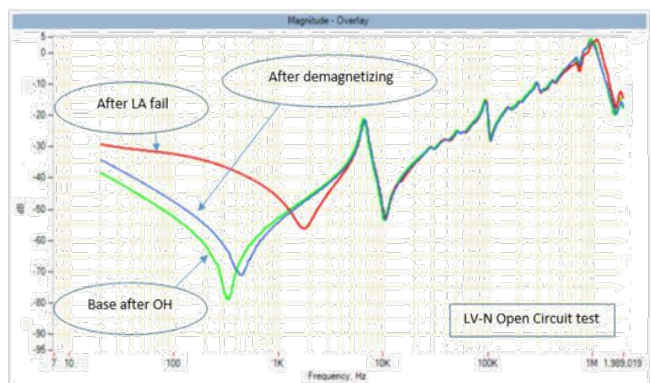
After demagnetizing, the trace of “L.V.-Neutral” in low frequency area also matched to a great extent - to the base fingerprint as shown in figure 9.

Fig. 9. SFRA of L.V. winding after demagnetization

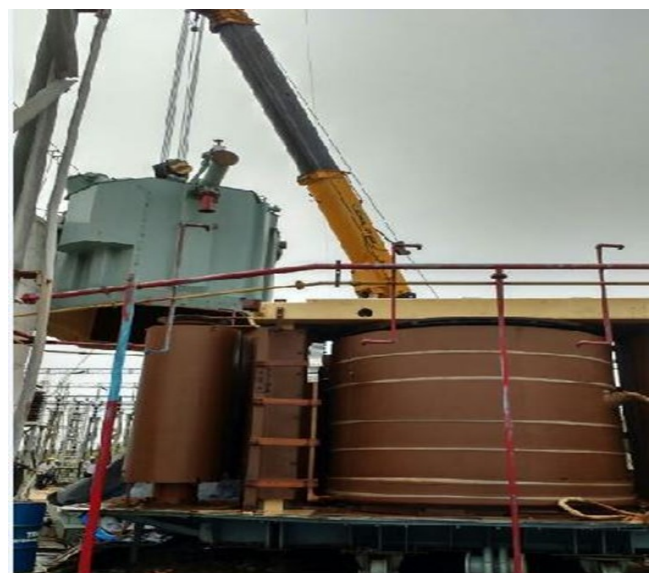
All test results found normal. Difference noticed in SFRA test results of tertiary winding indicated hoop buckling of tertiary winding, and same supported by capacitance and tan delta test, hence it was decided to inspect the transformer at site by lifting main tank. After removal of oil, thorough inspection of winding was carried out and nothing found abnormal in the transformer. No any black carbon particle or copper particle found inside main tank. After completion of internal inspection oil, filtration and drying out process for power transformer was carried out. All the required tests performed again. All the test results were found satisfactory or within permissible limit. The distortion in tertiary winding indicative from SFRA results - could not be observed / visualized after opening of transformer, as tertiary winding being innermost winding was surrounded by HV-IV winding - covered with hard board insulating cylinder. So nothing can be visualized for tertiary winding in inspection - as shown in figure 11.

Fig. 11. Inspection of active part of transformer

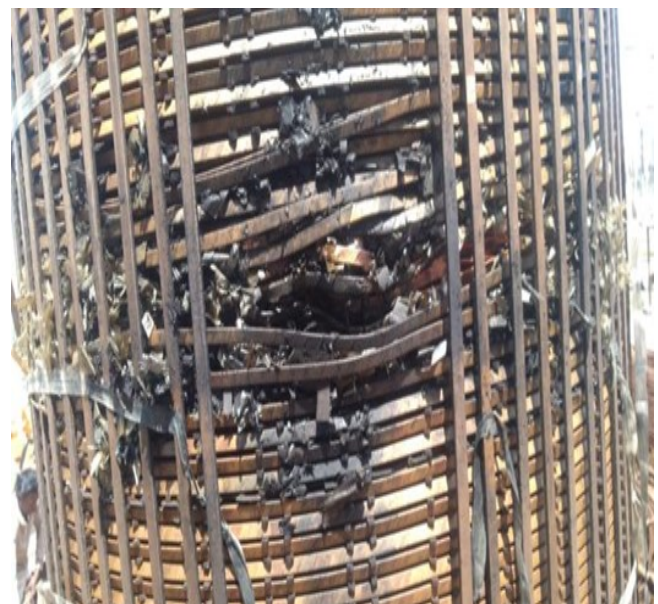
Transformer was declared failed with base of SFRA and other test results, for verification of turn to turn shorting in tertiary winding, transformer was decided to open again and inspect the tertiary winding. After opening of transformer at site. H.V. and L.V. windings found intact and turn to turn shorting observed in tertiary as shown in figure 15.

Fig. 15. Buckled tertiary winding with turn to turn short

Transformer scraped and declared fail. To confirmed analysis of SFRA result for turn to turn shorted in tertiary winding proved with physical inspection at field level.
