ACTA TECHNICA CORVINIENSIS – Bulletin of Engineering | e–ISSN: 2067 – 3809
Tome XVII [2024] | Fascicule 1 [January – March]

REPLACEMENT OF FLUORESCENT LIGHT SOURCES WITH LED

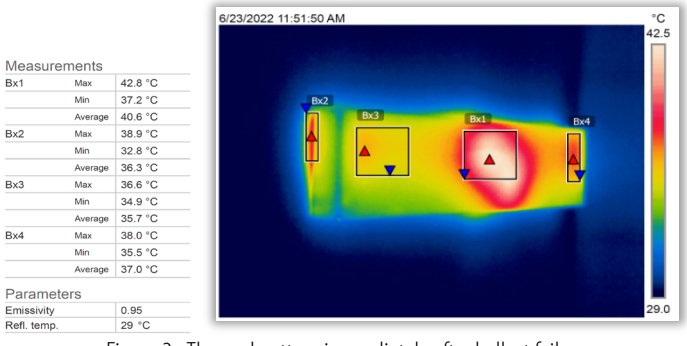
Motivation for this work was the failure (explosion) of the ballast of a FLU lighting fixture located in the cabinet 2-29 of the Faculty of Electrical Engineering, Computing Science and Information Technologies Osijek at the location Kneza Trpimira 2b. The lighting fixture was installed in 1995 as part of the modernization of the lighting system. On average, the light sources (tubes) were replaced every 5 years, while a visual inspection did not reveal any problems with the ballasts (change in color of plastic or connector). On June 23, 2022, the room temperature reached 29 °C. The cabinet, which is protected from the sun by tree canopies, must be artificially illuminated according to EN 12464-1:2021, [4] so the lighting was in operation. An explosion occurred in one of the lamps, accompanied by smoke and unpleasant odor. Thermographic inspection shows the first three minutes of the event, which caused a short circuit and turned off the entire lighting system. Figure 3 shows the thermal pattern immediately after the explosion.

Figure 3. Thermal pattern immediately after ballast failure

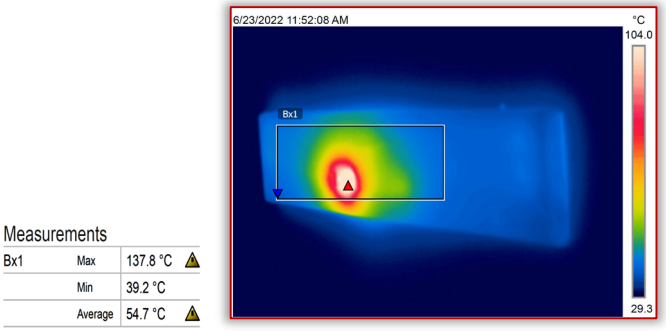
Figure 4 shows a piece of ballast that came loose and fell onto the diffuser of the lamp, causing the temperature to rise to 138 °C. After half a minute, another piece of ballast falls onto the diffuser, but it cools quickly. By removing the diffuser, the cause of the short circuit and the extent of the damage could be determined (Figure 6 and Figure 7).

Figure 4. A piece of molten ballast falls on the base of the diffuser

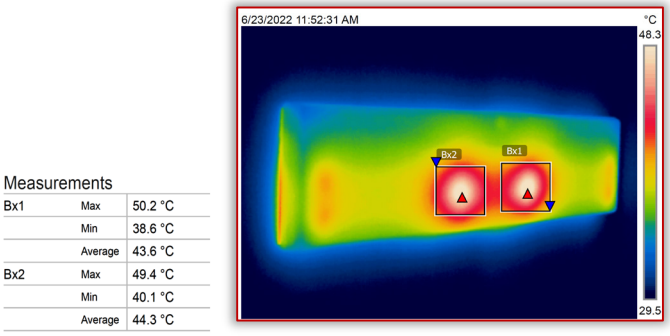
Figure 5. Two pieces of ballast on the base of the diffuser in gradual cooling

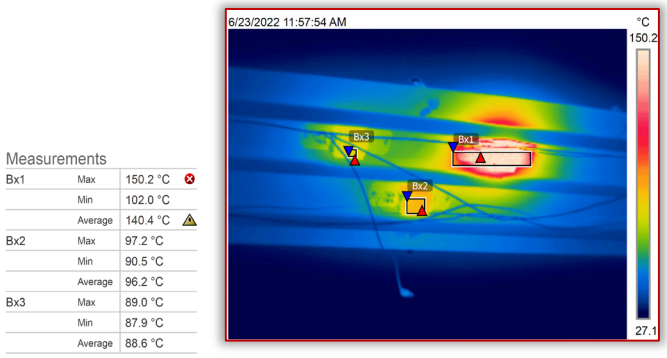
A thermographic inspection of the ballast also revealed the limitations of the Flir 60bx infrared thermal imaging camera, which measures up to 150°C. The indicated temperature does pose a

fire hazard, but due to the sheet metal support separated from the ceiling structure by joints and the design solution, the fire hazard is minimal. The approximate temperature of the other two ballasts can be seen in Figure 8 and is 90 °C.

Figure 8. Partial thermographic analysis due to the limited temperature range of the camera

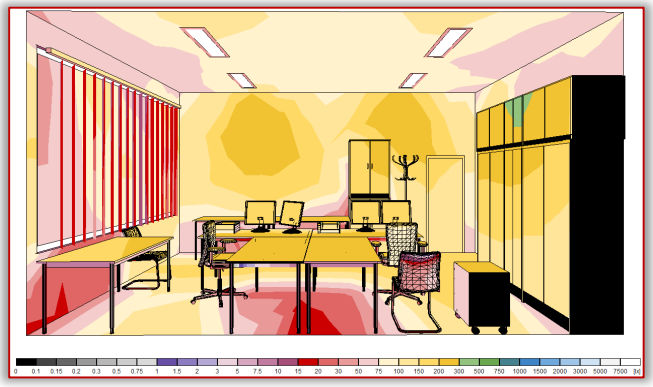
Figure 10. Analysis of the initial conditions assuming that all lighting fixtures are in operation

Before the lighting system was put into operation, it was necessary to plan corrective actions. The process begins with analyzing the initial condition by modeling the office space in RELUX program support and determining the lighting parameters, i.e., how they meet the requirements of the standard EN 12464-1:2021 Light and lighting - Lighting of work places - Part 1: Indoor work places. Figure 10 shows the situation where lighting levels on work surfaces do not exceed 300 lx. It was clear that simply replacing lamps was not the optimal solution.

The main problems of the existing system are the replacement and disposal of the FLU tubes every five years, the higher power consumption compared to today's affordable LED lighting and, above all, the impossibility of predicting the life of the remaining ballasts, which are 28 years old.

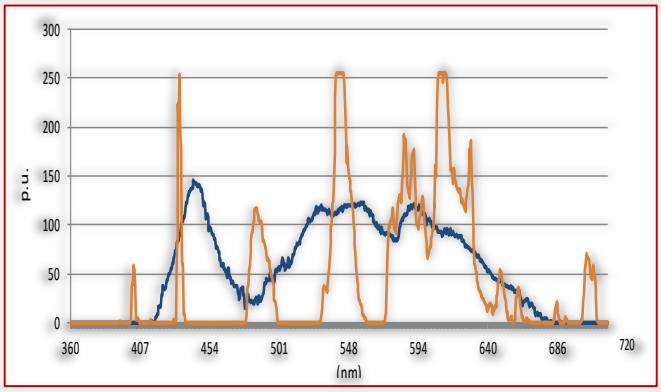
Figure 11. Comparison of the spectral composition of LED (blue) and FLU light source (orange)

Another benefit of replacing FLU with LED is seen in the potential reduction of the characteristic 100 Hz flicker of FLU, but also in the significant increase in color rendering index due to the richer spectral composition of the LED source. In Figure 11, the spectral composition of the LED illumination is represented by a blue curve, while the spectrum of the FLU illumination is represented by an orange curve [5]. The spectrometer used for the analysis of light sources for the purpose of this paper is SPECTRA 1, manufactured by Kvant [6].

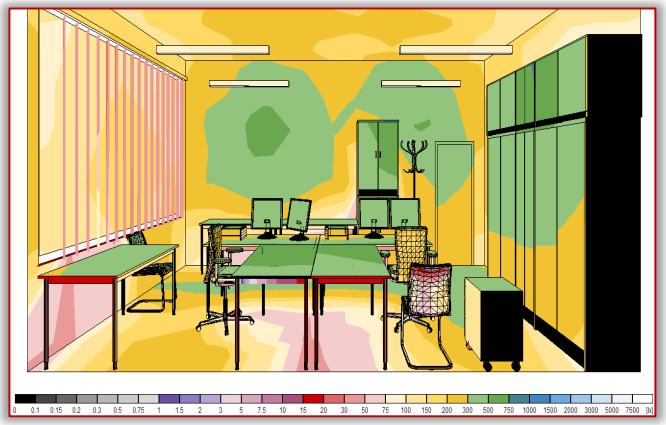
Figure 13. Results of surface illumination using Solo LED 55 W lamps

The analysis of the data obtained from the simulation shows that the new scene proposal provides values that comply with EN 12464-1:2021 and that the luminous flux of 6000 lm per lamp meets the needs of the users of the room with an illuminance of 500 lx to 750 lx on the work surface.
