Artificial lakes: Problems and solutions

Man Teodor Eugen¹, Ienci Ioan Catalin¹

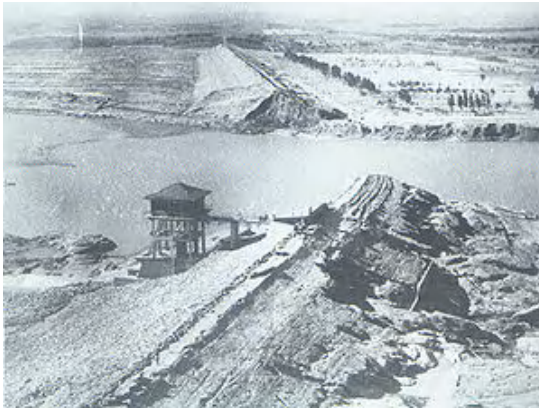
Banqiao Dam (Fig. 3) was built in the early 1950s on the Ru River as part of a project to control flooding and generate electricity and as a response to severe flooding in the Huai River basin in 1949 and 1950. The dam was 118 meters tall and had a storage capacity of 492 million m^3 , 375 million m^3 reserved for storing water from floods. After completion the

Fig.3 Banqiao Dam after the break.

The dam was designed to survive a flood of 0.1% (once every 1,000 years) insurance. However, in August 1975 has been a flood of 0.05% (once every 2,000 years) insurance, the water of rainfall in 24 hours exceeded rainfall for a whole year (new records were set, to 189.5 mm / h and 1060 mm / day) so that weather forecasts failed to predict it.

On August 7 at 21:30, 34450 unit of the People's Liberation Army, who were at the Banqiao dam, sent the first warning of a dam failure by telegraph. On August 8, 0:30, the smaller Shimantan dam upstream, which was designed to withstand a flood with 0.2% (once every 500 years) insurance, had to take a quantity of water twice as that and broke, just 10 minutes after the 34450 unit sent a request that would open the dam Banqiao by air attack. A half hour later, the water discharged over the dam and Banqiao broke at 1:00. This led to failure of 62 dams in total.
