## The Reservoir for snow-drifting from Poiana Brașov

**Abstract** - One of the objectives of the developing and rehabilitation of the skiing area in the Poiana Brașov resort is represented by the reservoir for snow-drifting in Poiana Ruia. This reservoir is bordered by the mountainside upstream and by a quasi-circular embankment dam downstream. The lake is sealed both on the bottom and on the gradients with several layers of clay, geo-textile, gravel and high-density plastic sheet. The water taken from the mentioned lake is pumped to the artificial snow producing devices. The natural conditions of the reservoir imposed the design solutions presented in this paper.

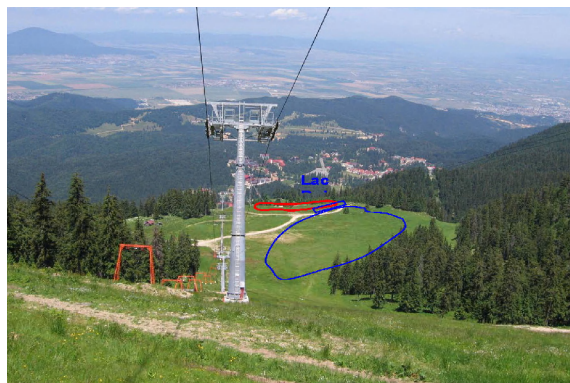
**Fig. 1** The site of the future Poiana Ruia reservoir

The site of the reservoir is between the 1475,00 m. and 1500 m. heights, at about 1,5 kilometers, at the highest slope from the habitable area of the Poiana Brașov resort.

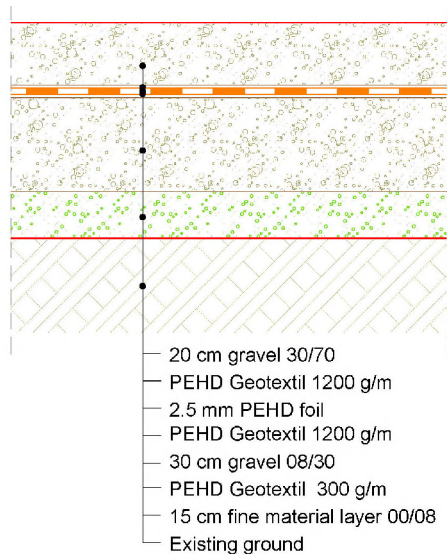
**Fig. 3. Sealing coat of the lake's bottom**

The reservoir is sealed both on the bottom and on the slopes by several strata of clay, geo-textile, gravel and high-density plastic sheet. presented in Figures 3 and 4.
